COLD STORAGE WAREHOUSE

Madison, WI

May 3, 1991

\$100 Million Fire Destroys Warehouses

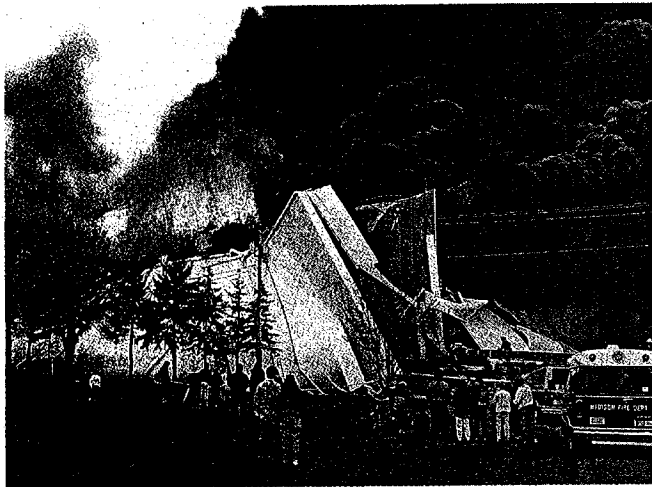
The foam insulation contained in Freezer 8's walls, partitions, and roof generated heavy black smoke as it burned. This photograph was taken from the northeast corner of Freezer 8.

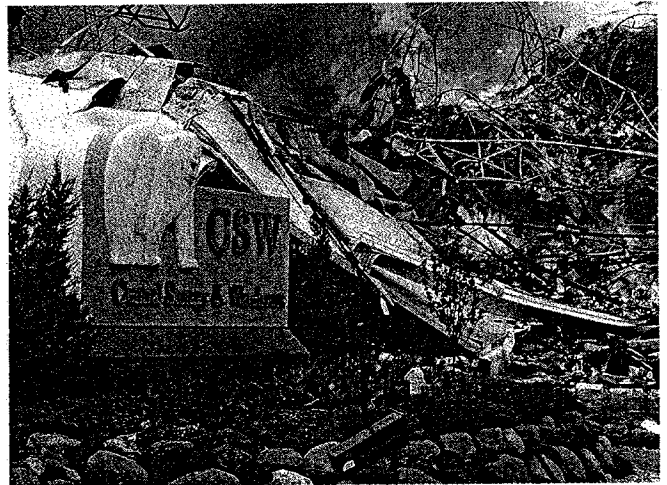
Five days after the fire had started, deep-seated fires still burned in the rubble. They were extinguished as heavy equipment uncovered them.

On May 8, five days after the fire had started, deep-seated interior fires still burned. They were extinguished as heavy equipment, used to remove debris, uncovered them. On Saturday, May 11, the fire department declared the fire extinguished.

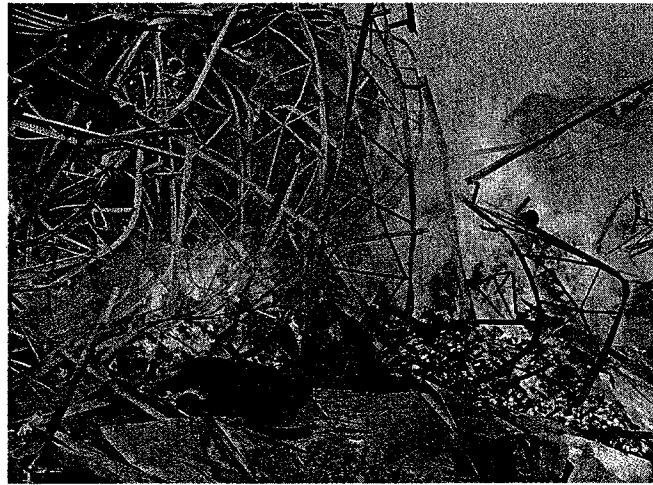
The light metal frames of the fire building's storage racks supported both the stored commodities and the warehouse roof assembly.

The building's structural design affected fire suppression tactics and strategies. The vertical structural members in the storage racks provided support for the roof above Freezer 8. Apparently, the fire—in combination with the loads from the roof assembly and stored commodities—began affecting the structure's integrity early in the incident. Because both the incident commander and Engine 5's officer felt there was a serious threat of collapse during the fire's early stages, they did not allow crews to enter Freezer

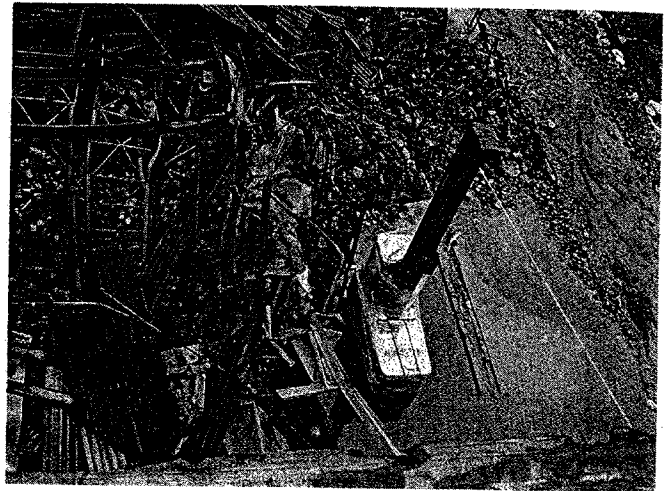
Investigators suspect that this forklift truck was near the point of fire origin, and they are studying it to determine whether it was involved in the fire's ignition.

The officer on Engine 5 indicated that an apparent pile of rubble was engulfed in yellow flames when he entered Freezer 8 and that the fire did not appear to be extending to the ceiling. Fire department investigators determined that the burning rubble probably included a large electrical forklift. Other investigators are studying the forklift to determine whether it was involved in the fire's ignition.
