## HOSPITAL FIRE

Weymouth, MA  
January 24, 1993

### **FIRE INVESTIGATION REPORT**

**HOSPITAL FIRE**

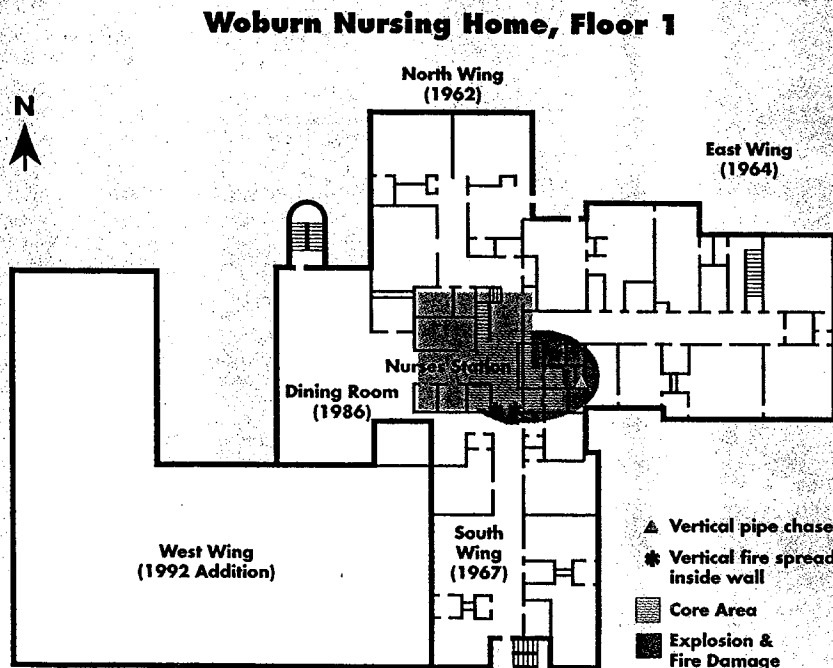
FIGURE 1

**The fire and explosion occurred in the central core area on the first floor of the Woburn Nursing Center. Residents' room were in wings surrounding the core area.**
