**Federal Express DC-10 Landing Gear Collapse**  
**Memphis, Tennessee**  
*December 18, 2003*

**Presented By:**  
**Captain Brian Boucher**  
**Air Canada**

**Presented at:**  
**The International Forum on Emergency and Risk Management**  
**Singapore Aviation Academy**  
**10-12 January, 2005**

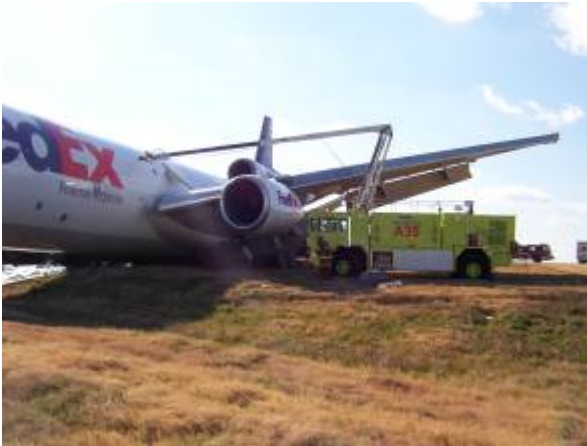
The penetrator made entry approximately 3 meters aft of the cargo and about 14 inches above the window line. The fire was burning intense almost directly across the cabin and starting to penetrate the interior. Water and foam was now being discharged into the cabin at approximately 1000-1200 LPM. They were now 6-8 minutes into the event and the fire started to shows signs of subsiding.

Examination of the aircraft interior after extinguishment revealed that the area in front of the wing attachment root was penetrated by the fire in three places. The skin forward of the right wing was severely damaged and melted away for about a 8 meter area along the fuselage. Only the support stringers were left. The fire penetrated at the floor line at the air-conditioning grill distribution area. It further penetrated the sidewall fiberglass panels approximately two meters from the floor at an overlap seam in the interior. The final flame penetration source was about a 1x3 meter area along the ceiling of the aircraft approximately 2 meters from the floor and forward of the wing root. This area only had the installation batten material hanging from the upper attachment point. The fiberglass interior panels were destroyed showing that a severe fire had gotten inside the fuselage. The piercing nozzle mounted on A-35 (Oshkosh 6,000liter/elevated waterway) was

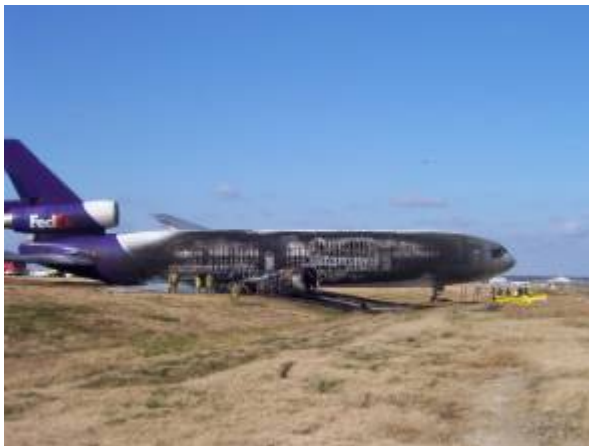
A three dimensional fire continued to burn and with the help of firefighters on the ground with their twin agent line, they were able to extinguish the remaining fire in about 10-12 minutes from when they arrived at the scene. The reason for this, was because most of the fuel from the left wing was being transferred into the center of the fire area and continued to feed the fire.

MCFD and FedEx FD had control of the fire. The combined total of approximately 20,000 liters of water from the three responding trucks was utilized to gain control of the fire. An additional ten minutes and approximately 4,000 liters of extinguishing agent were used to subdue the stubborn-three-dimensional running fuel fire on the right wing root area using hand lines from A-35 (Oshkosh 6,000 liter/elevated waterway) and the 1000 mm supply line from E-33 (Backup structural truck from the airports Station 33, supported by the MCFD engine company). E-33 was attempting to put out some residual fire on the right side of the aircraft. They did not have any more water at that time so the 200 millimeter preconnect from A-35 was taken under the aircraft and given to the E-33 crew.

In the end, total extinguishment time was 20-25 Minutes.
