# Fire Investigation Summary

# Supermarket

**Phoenix, Arizona**  
**March 14, 2001**

National Fire Protection Association  
Fire Investigations Department

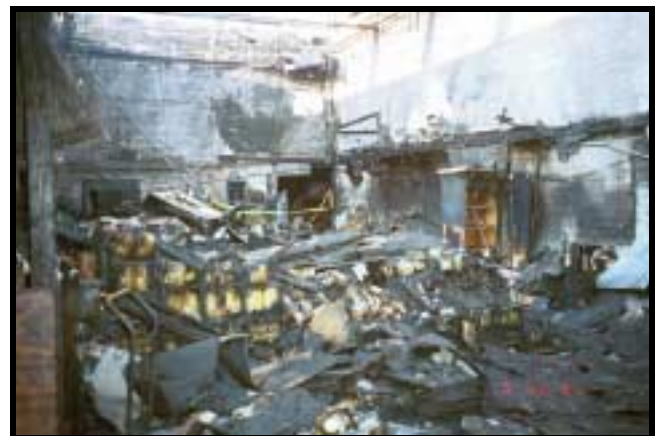
**View of supermarket stock room  
(NFPA)**

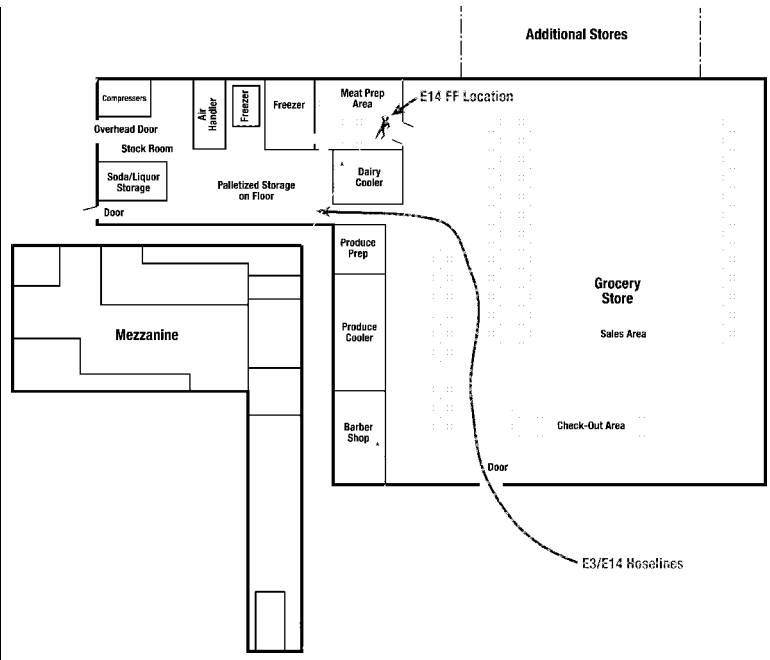
Building Layout/FF Location

Several Rapid Intervention Crews (RICs) were sent to search for the remaining missing fire fighter, as conditions within the store worsened. Eventually the missing fire fighter was located, unconscious in the meat preparation portion of the store. Removal of the fire fighter was difficult due to his size and the obstructions located in the storage room and in the path to the exit. His removal required several additional crews. He was eventually removed through the storage room in the southeast corner of the store. He was transported to the hospital where he was pronounced dead.
