Fire Investigation Summary

Apartment Building Fire

**Bremerton, Washington
November 13, 1997**

National Fire Protection Association
Fire Investigations Department

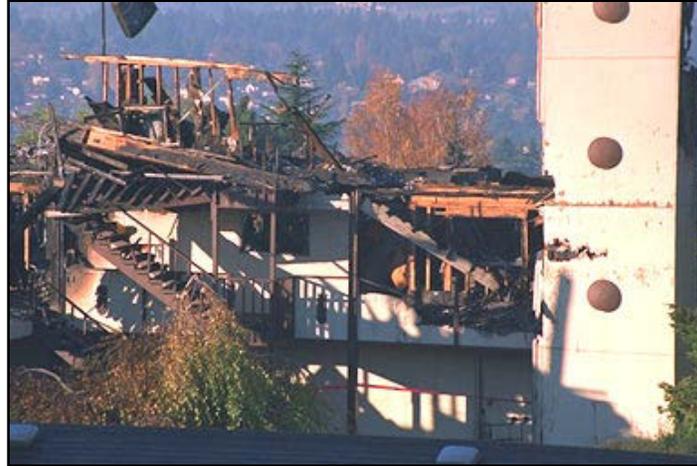
The apartment complex manager was delivering newspapers to various units when he heard the sound of the smoke detector. He entered the unit to investigate and reported that smoke had filled the unit to within a foot of the floor. He could see a body of fire in the unit's front bedroom.

The manager then exited the unit, leaving the door open, and began banging on doors in the vicinity of the fire apartment to notify other occupants of the fire.

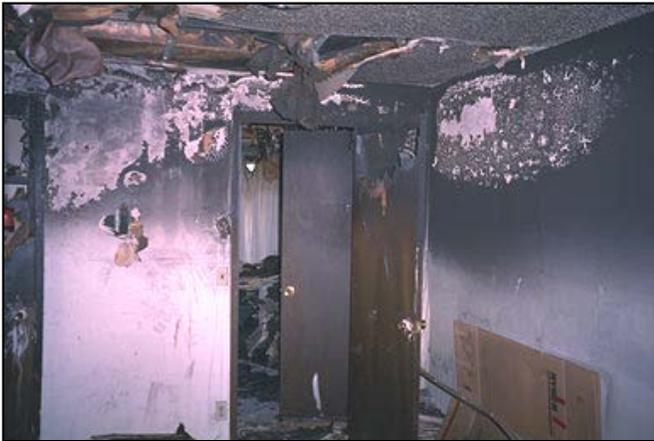
According to accounts provided by some of the residents, they were unaware of the fire until they were trapped within their units. The woman directly above the fire apartment was awake and lying in bed at the time of the fire. She reported that her window exploded inward upon her and that fire entered her apartment through this window.
