# Fire Investigation Summary

## **North York**

**Residential High-Rise  
North York, Ontario  
January 6, 1995**

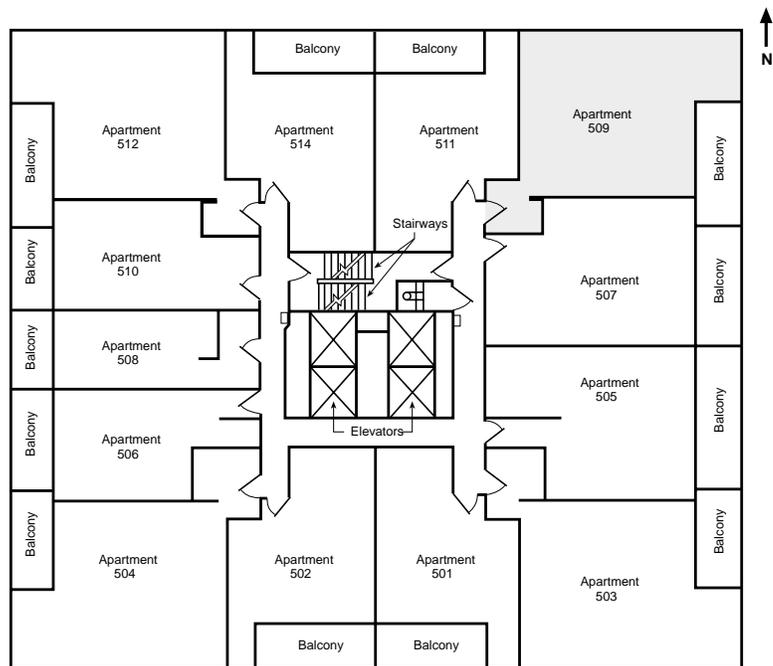
5th FLOOR ARRANGEMENT

After unsuccessfully attempting to extinguish the fire, the occupant in the apartment of fire origin left without closing the dwelling unit door to the corridor. Fire and smoke passed through the open door into the exit access corridor and made that corridor untenable for many fifth-floor residents. The residents who did not escape early in the incident stayed in their apartments until they were rescued by fire fighters. The combination of closed doors and noncombustible walls prevented untenable conditions and deaths from occurring in other fifth-floor apartments.

The door to one of the building's two exit stairways was heavily damaged by the fire, and the door to the other exit stairway was held open by a fire department hoseline used during the fire suppression operations. As a result, smoke entered both stairways. Natural stack effect moved the smoke vertically through the stairways, elevator shafts, and heating, ventilation, and air conditioning ducts. On the upper floors, the smoke passed through open doors and seeped past closed
