Fire Investigation Summary

Apartment Building Fire

**Bremerton, Washington
November 13, 1997**

National Fire Protection Association
Fire Investigations Department

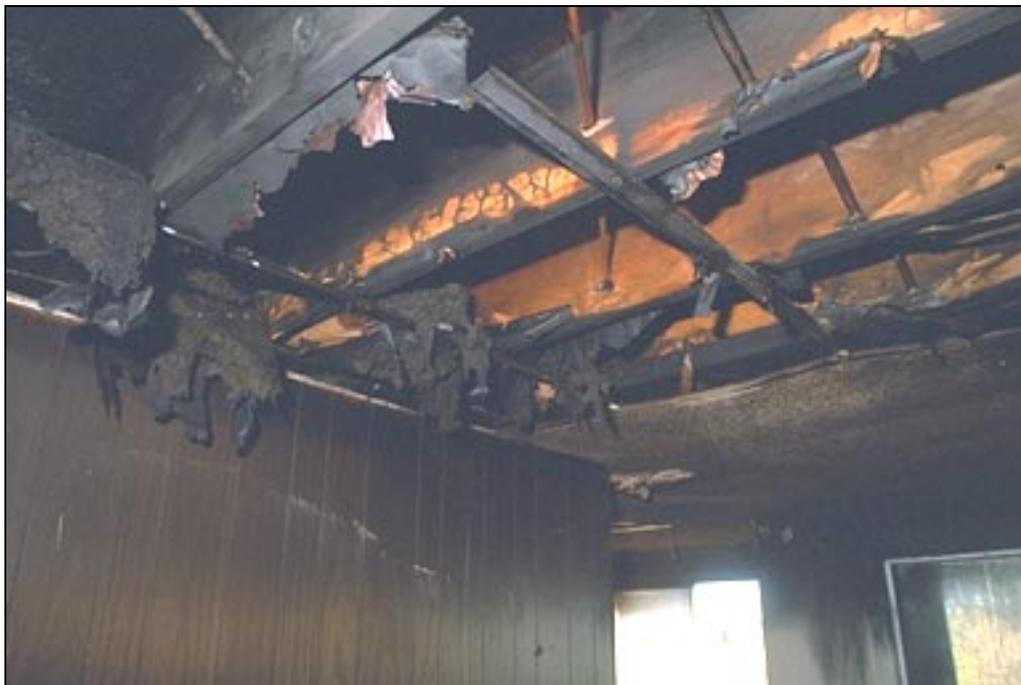
Photo 1. A view of the ceiling/floor assembly inside a damaged apartment.

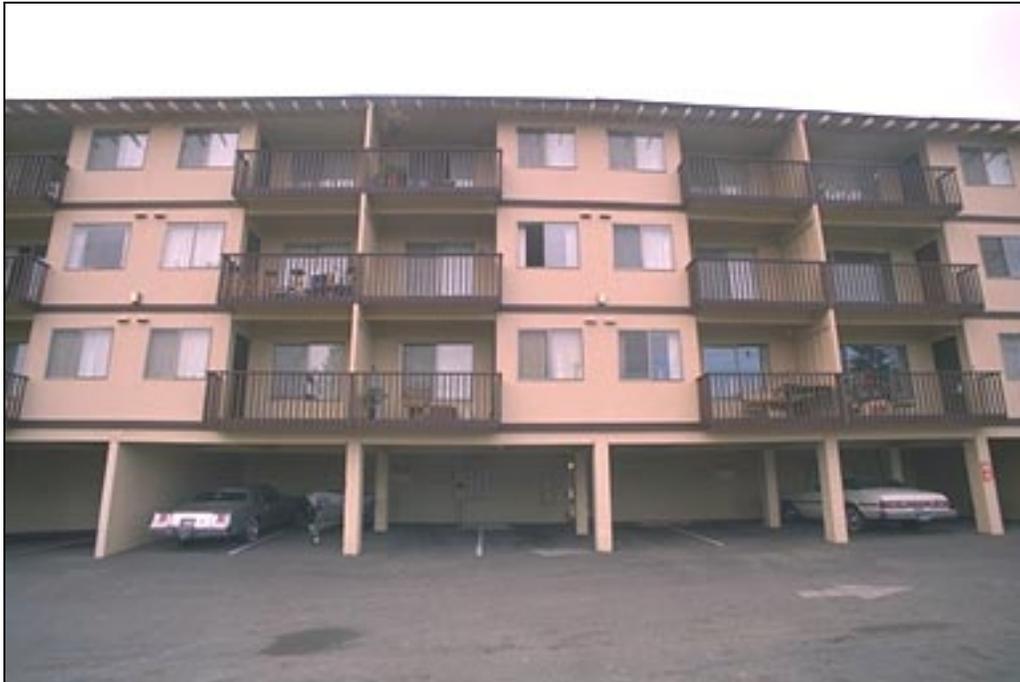
Photo 2. The exterior, or outboard, side of the apartment complex.

The building most closely resembled Type V (000) construction according to the criterion in NFPA 220, *Standard on Types of Building Construction*, 1995 edition. (See Photo 2.)

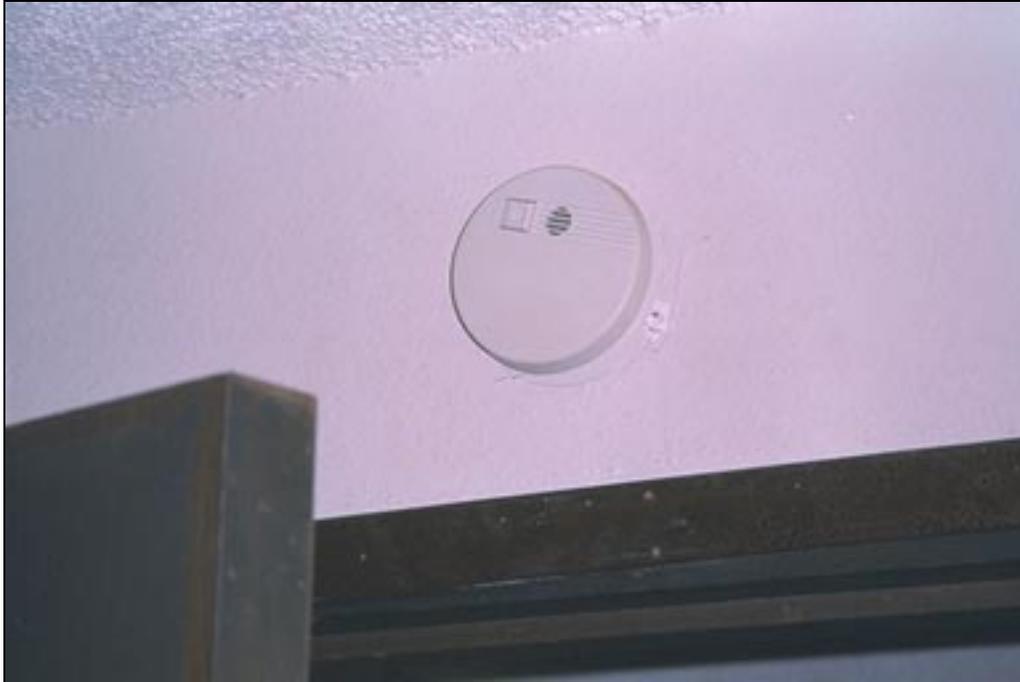
Photo 3. The only fire alarm devices were single-station, battery-powered smoke detectors in each living unit. There was one device per unit.

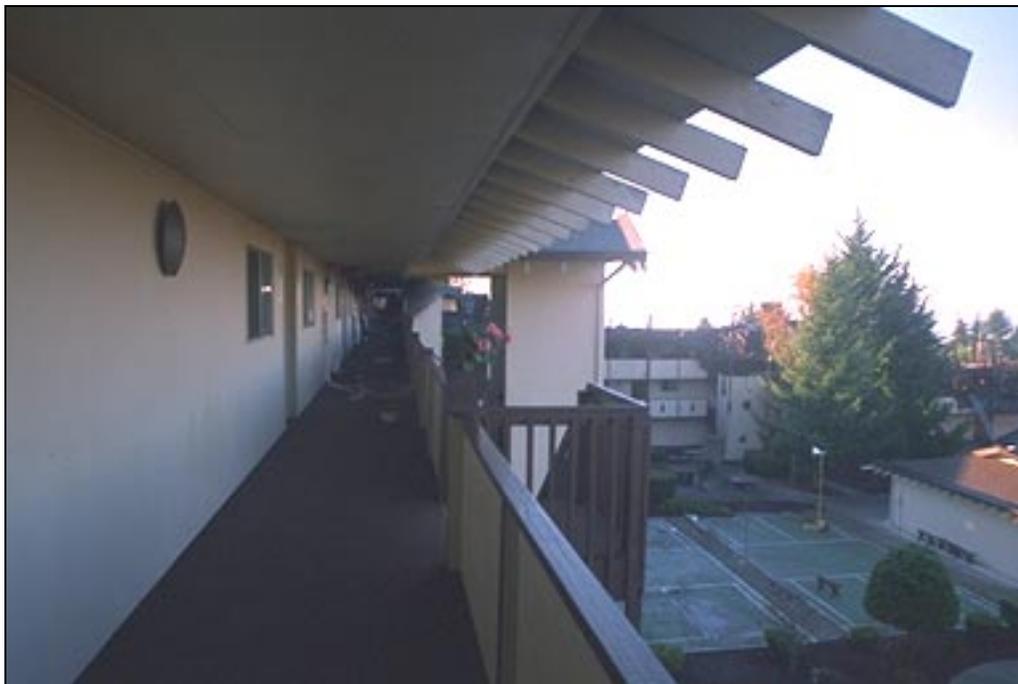
Photo 4. A view of one of the balconies on the fourth level looking from east to west toward the damaged corridor. One of the stairways is seen in the middle of the picture.

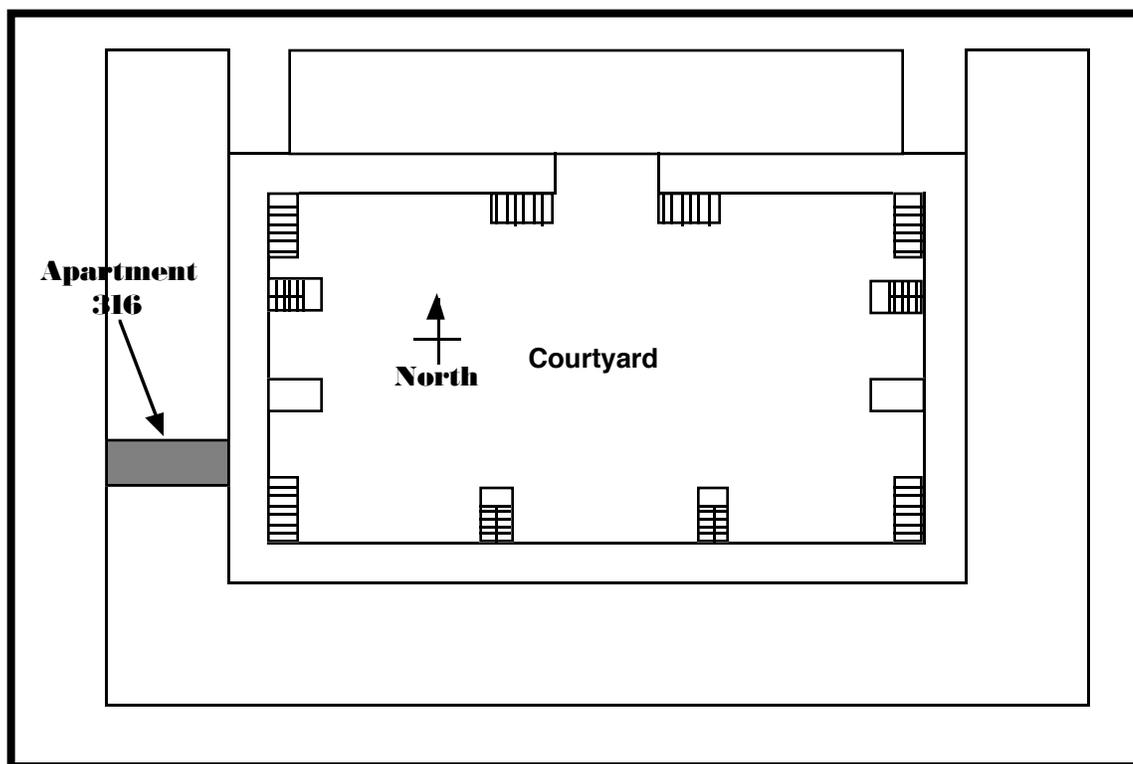
At approximately 6:00 a.m., the manager of the apartment complex was delivering newspapers to various apartments. He reported that he heard a smoke detector going off in apartment 316. He returned to his apartment, called 911 to report the fire, picked up his master key and a flashlight and went to apartment 316 to investigate. When he opened the door, he reported that the apartment was filled with black, heavy smoke, almost down to the floor level. He got down on his stomach and crawled into the apartment about four or five feet to see if there were any people inside. When he entered, he looked to his right and could see flames in the area of the bed, against the courtyard side wall. He reported that the fire was not very large at this point in time. (See Figure 8.)

Figure 8. Site plan showing the apartment of fire origin on the third floor.

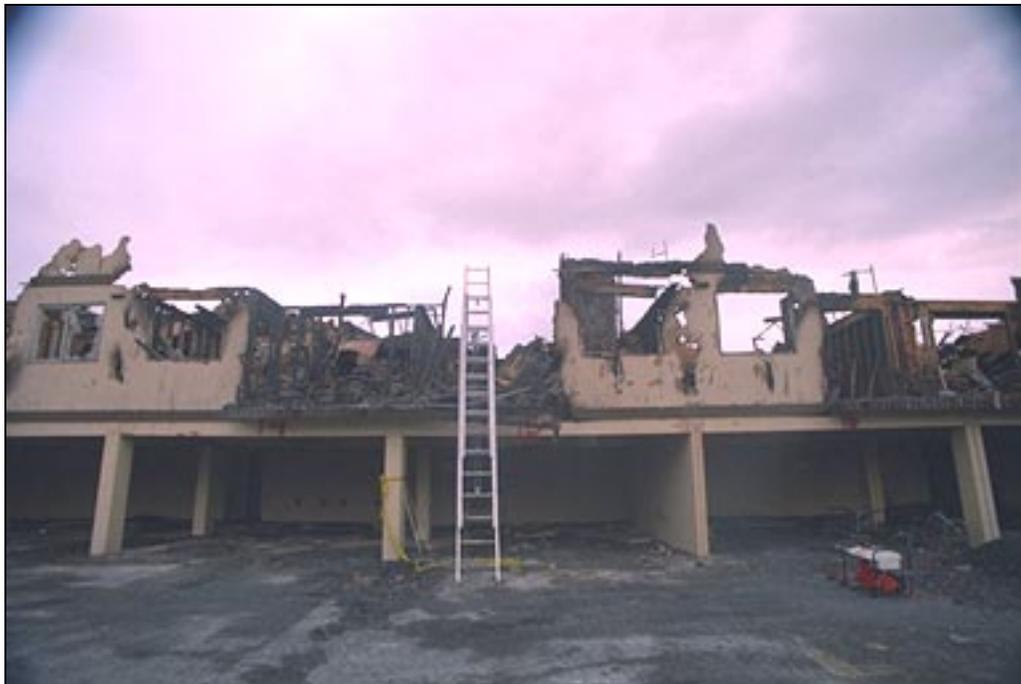
Photo 5. Photo from the west showing the remaining two floors below the area of origin. The apartment of origin was the third-floor apartment located above the ladder.

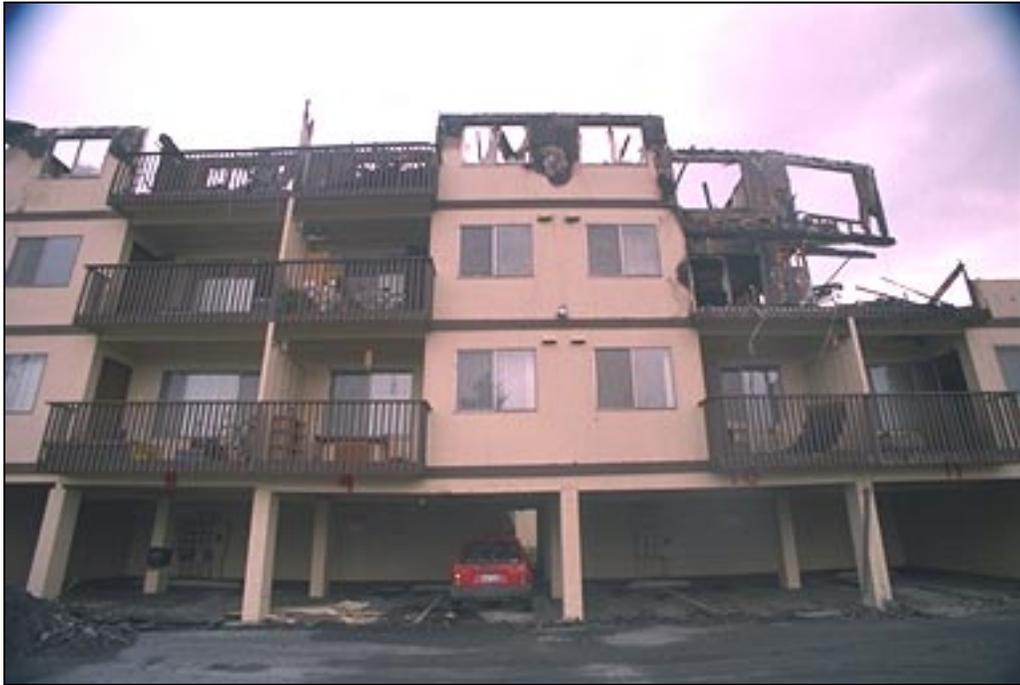
Photo 6. View of the diminishing fire damage as one moved further north from the area of origin on the west wing.

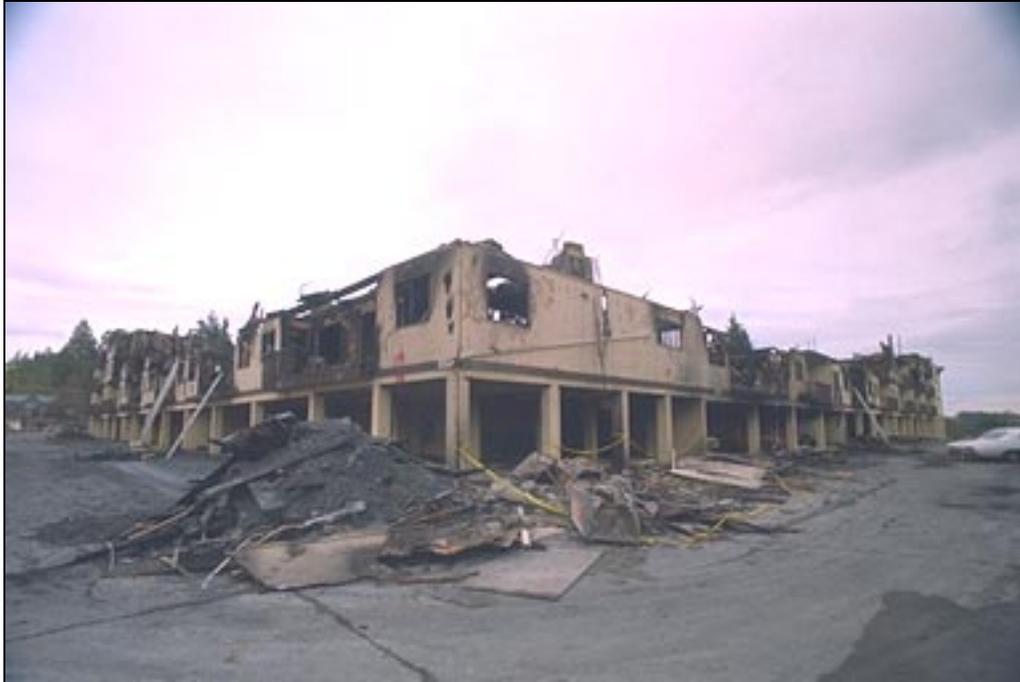
Photo 7. View of the southwest corner of the complex. The apartment of origin was on the third floor, above where the ladder is seen on the left.

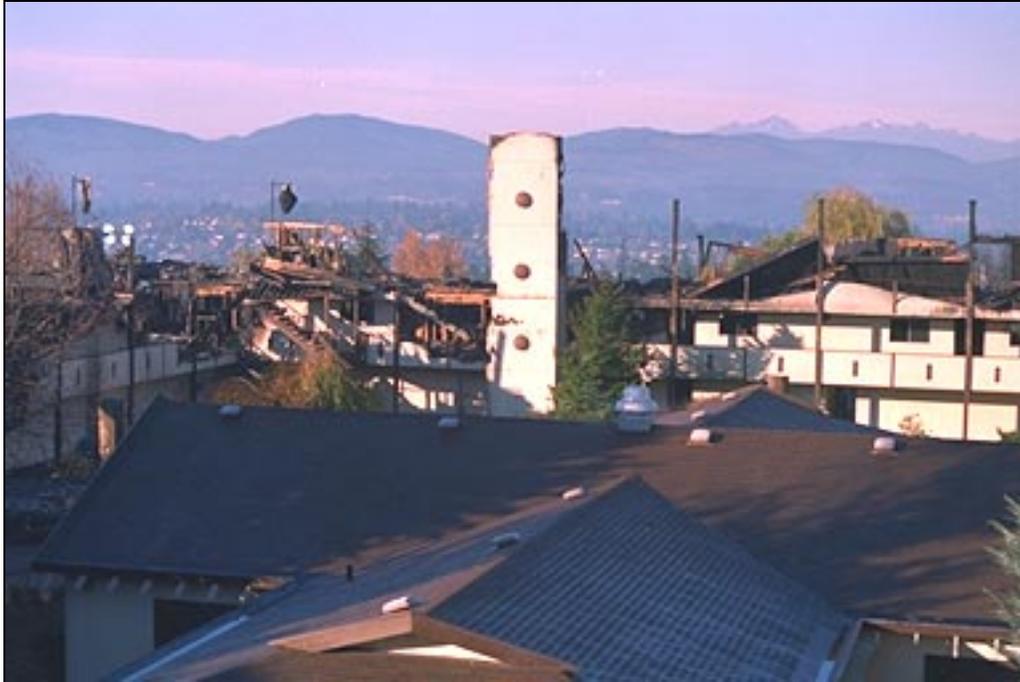
Property damage was assessed at \$7.5 million. All three occupied floors of the southwest corner were destroyed. From the southwest corner along the south and west wings, the extent of damage to the occupied apartments gradually decreased the further away from the area of origin.

The roof structure of the south and west wings were totally destroyed as was a portion of the roof structure on the east wing. Ultimately, the entire building was demolished because of the extensive damage. (See Photo 8.)

Photo 8. View towards the southwest corner of the complex that included the apartment of origin. The upper two stories were completely burned off.

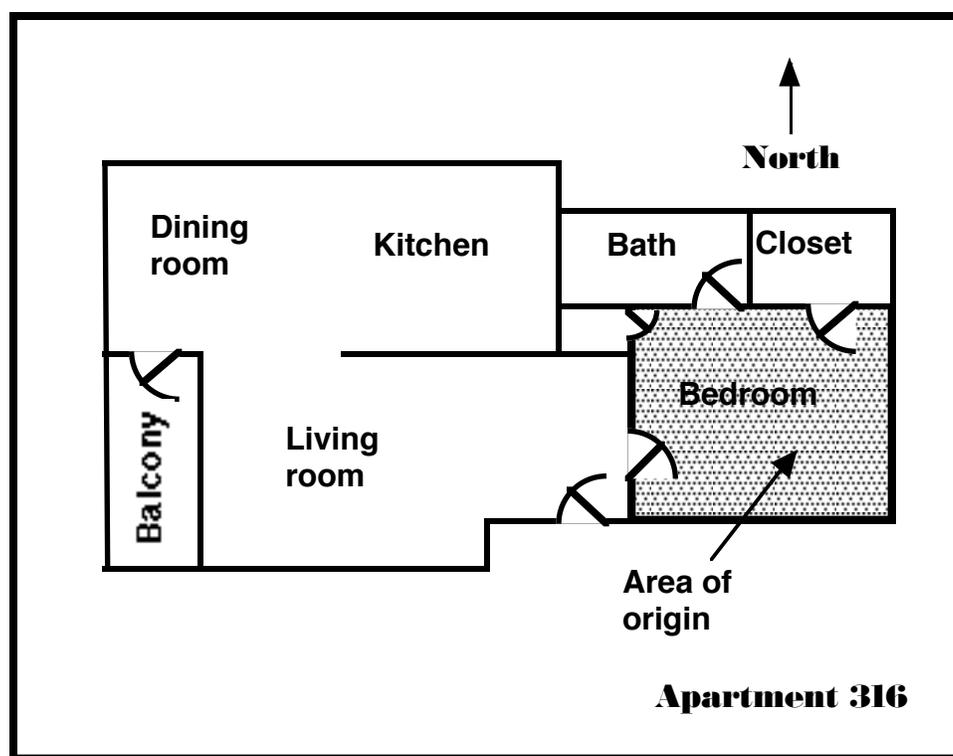
A joint investigation was conducted by the Bremerton Fire Department and the Bureau of Alcohol, Tobacco and Firearms. The cause of the fire was determined to be either an electrical baseboard heater or an electrical outlet on the courtyard side bedroom wall of apartment 316. The apartment was normally occupied, but at the time of the fire the occupant was not in the apartment. (See Figure 10.)

Figure 10. The layout of the apartment of origin showing the area where investigators determined the fire started.

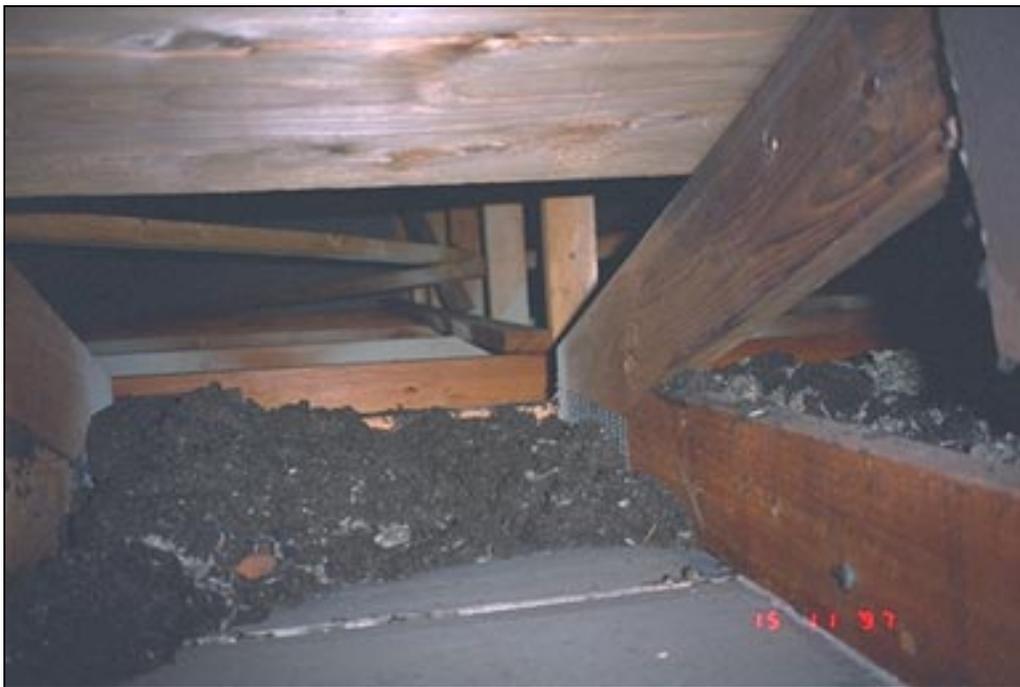
When the remaining fire barrier was inspected, it was noted that it was not continuous to the eaves. A large opening existed on the courtyard side of the structure. It was not possible to inspect the outboard side to determine if there was a similar opening.

point, it spread very rapidly, both laterally and vertically on the west wing, fueled by both the combustible exterior finish and the combustible structural components of the balconies and exterior exit stairways. The fire also spread into the combustible void space of the roof structure and spread laterally throughout the void space. Reportedly, there were four fire barriers within the void space. When the sole remaining barrier was inspected, openings were observed at the eaves. If this was the case on the other three barriers, then these openings would have served as an avenue for fire spread within the void space. (See Photo 9.)

Photo 9. Within the attic area, the fire separations were not continuous to the eaves. To the right, one can see the opening that existed where the fire separation was not continued.

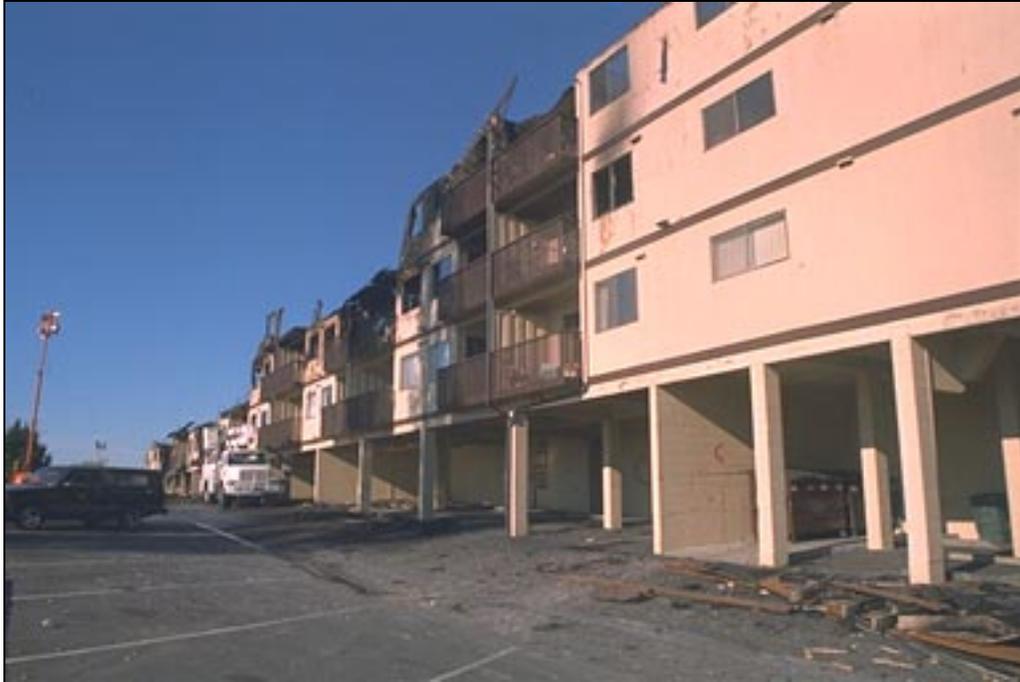
When the fire encountered the southwest corner, it turned and began spreading to the east on the third and fourth floors. Based on video taken by a traffic helicopter at 6:15 a.m., the fire had involved most of the third and fourth floors on the west wing and half of the south wing on the third and fourth floors.

Photo 10. View from the southeast corner looking towards the area of origin showing the progression of damage that occurred.
