**DWELLING FIRE**

Bellmore, NY

February 9, 1984

Investigation Report

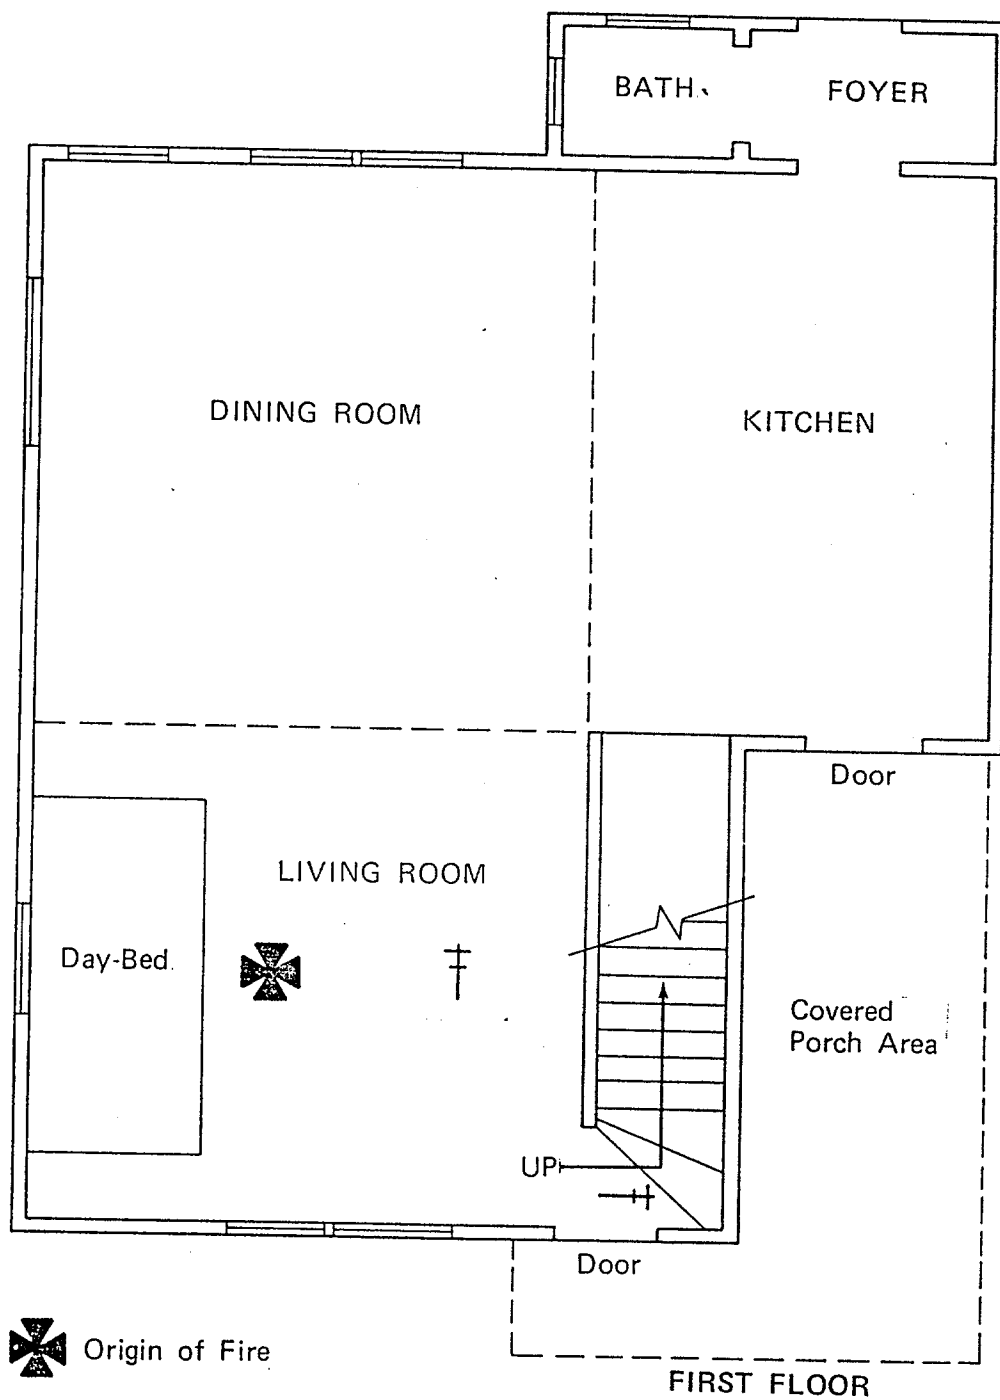
Figure 1. First Floor Plan and Victim Location

Once access was gained, search and rescue operations were begun by fire fighters with self-contained breathing apparatus (SCBA). Search and rescue operations were reported to have been hampered by the severe fire conditions and the amount of clutter within the interior of the building. Fire fighters were able to rescue a 9-year-old male from the front, second story bedroom area. This victim, however, was pronounced dead on arrival at an area hospital. During the suppression of the fire, fire fighters located an additional six persons within the building. Two victims were found in the first floor living room area and the remaining victims were located in the bedrooms on the second floor.
