SERVICES BUILDING

Summary Investigation Report

Four Fire Fighter Fatalities Brackenridge, Pennsylvania December 20, 1991

**Prepared by
Michael S. Isner
Fire Protection Engineer
National Fire Protection Association**

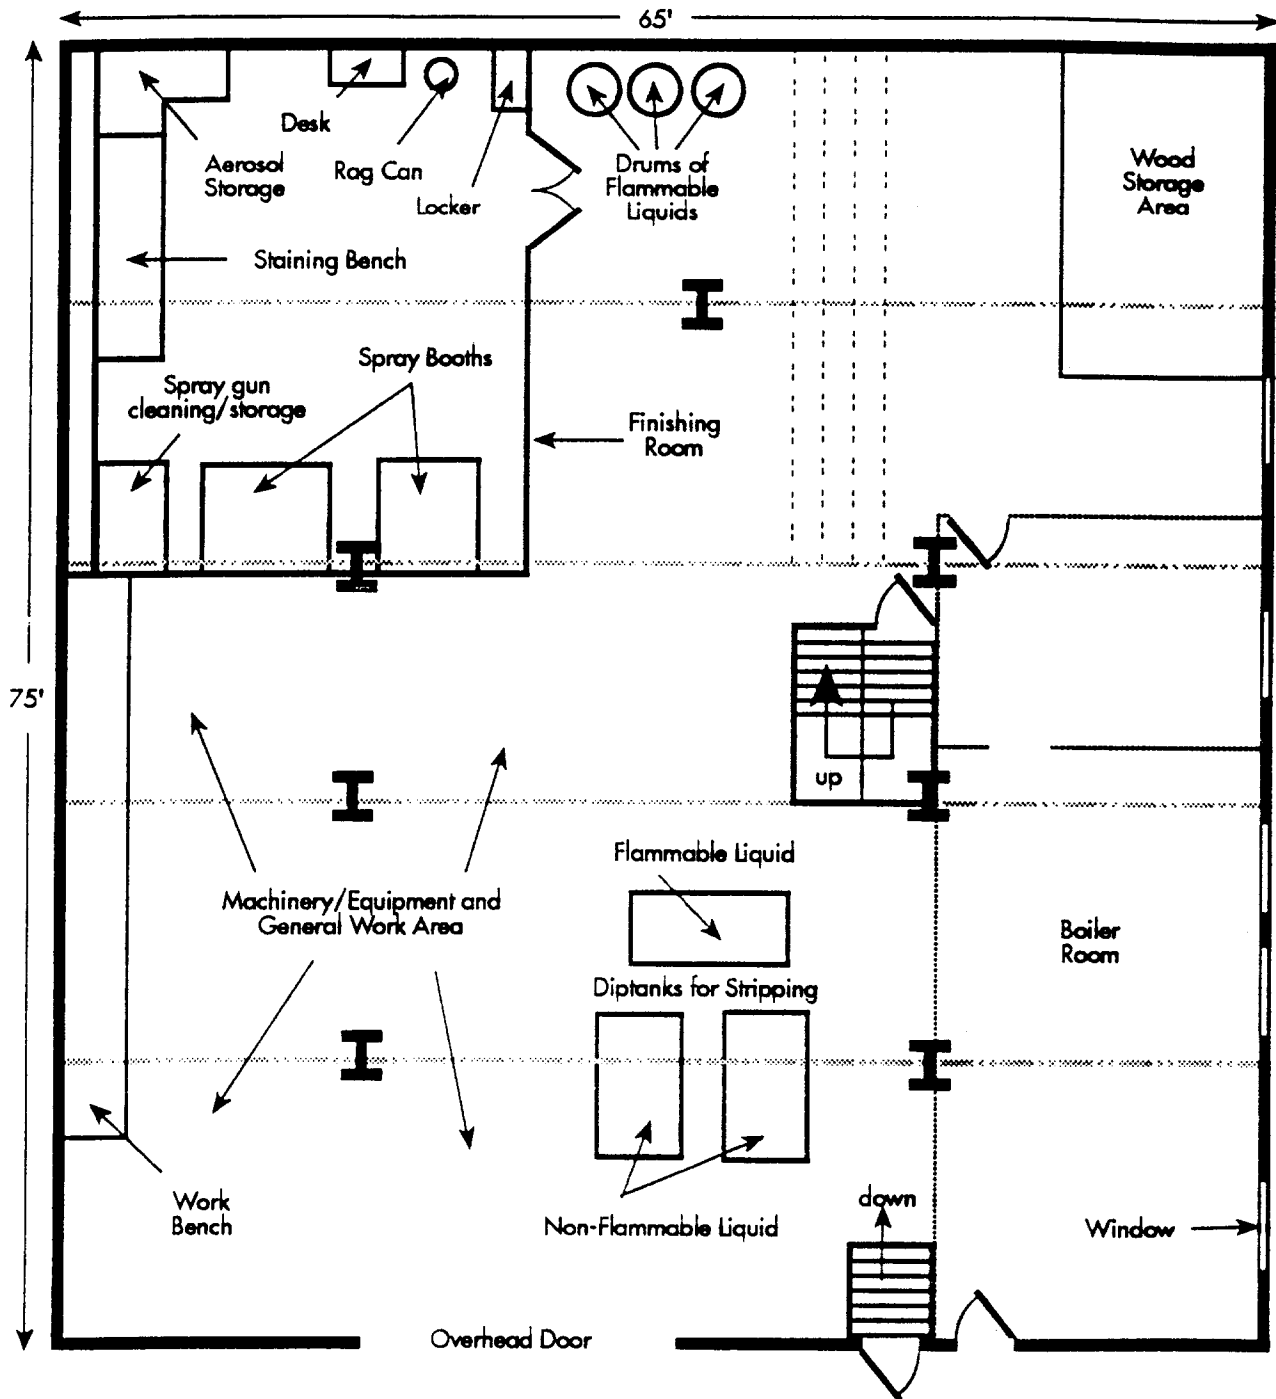
**WEST INTERIOR SERVICES
BASEMENT PLAN
Figure 1**

All work on furniture was performed in the basement, which opened out to grade at the rear of the building. The basement production area was divided into several sections that included a dipping/stripping area, a machinery/equipment area, materials storage areas, and a finishing room. (See Figure 1.)

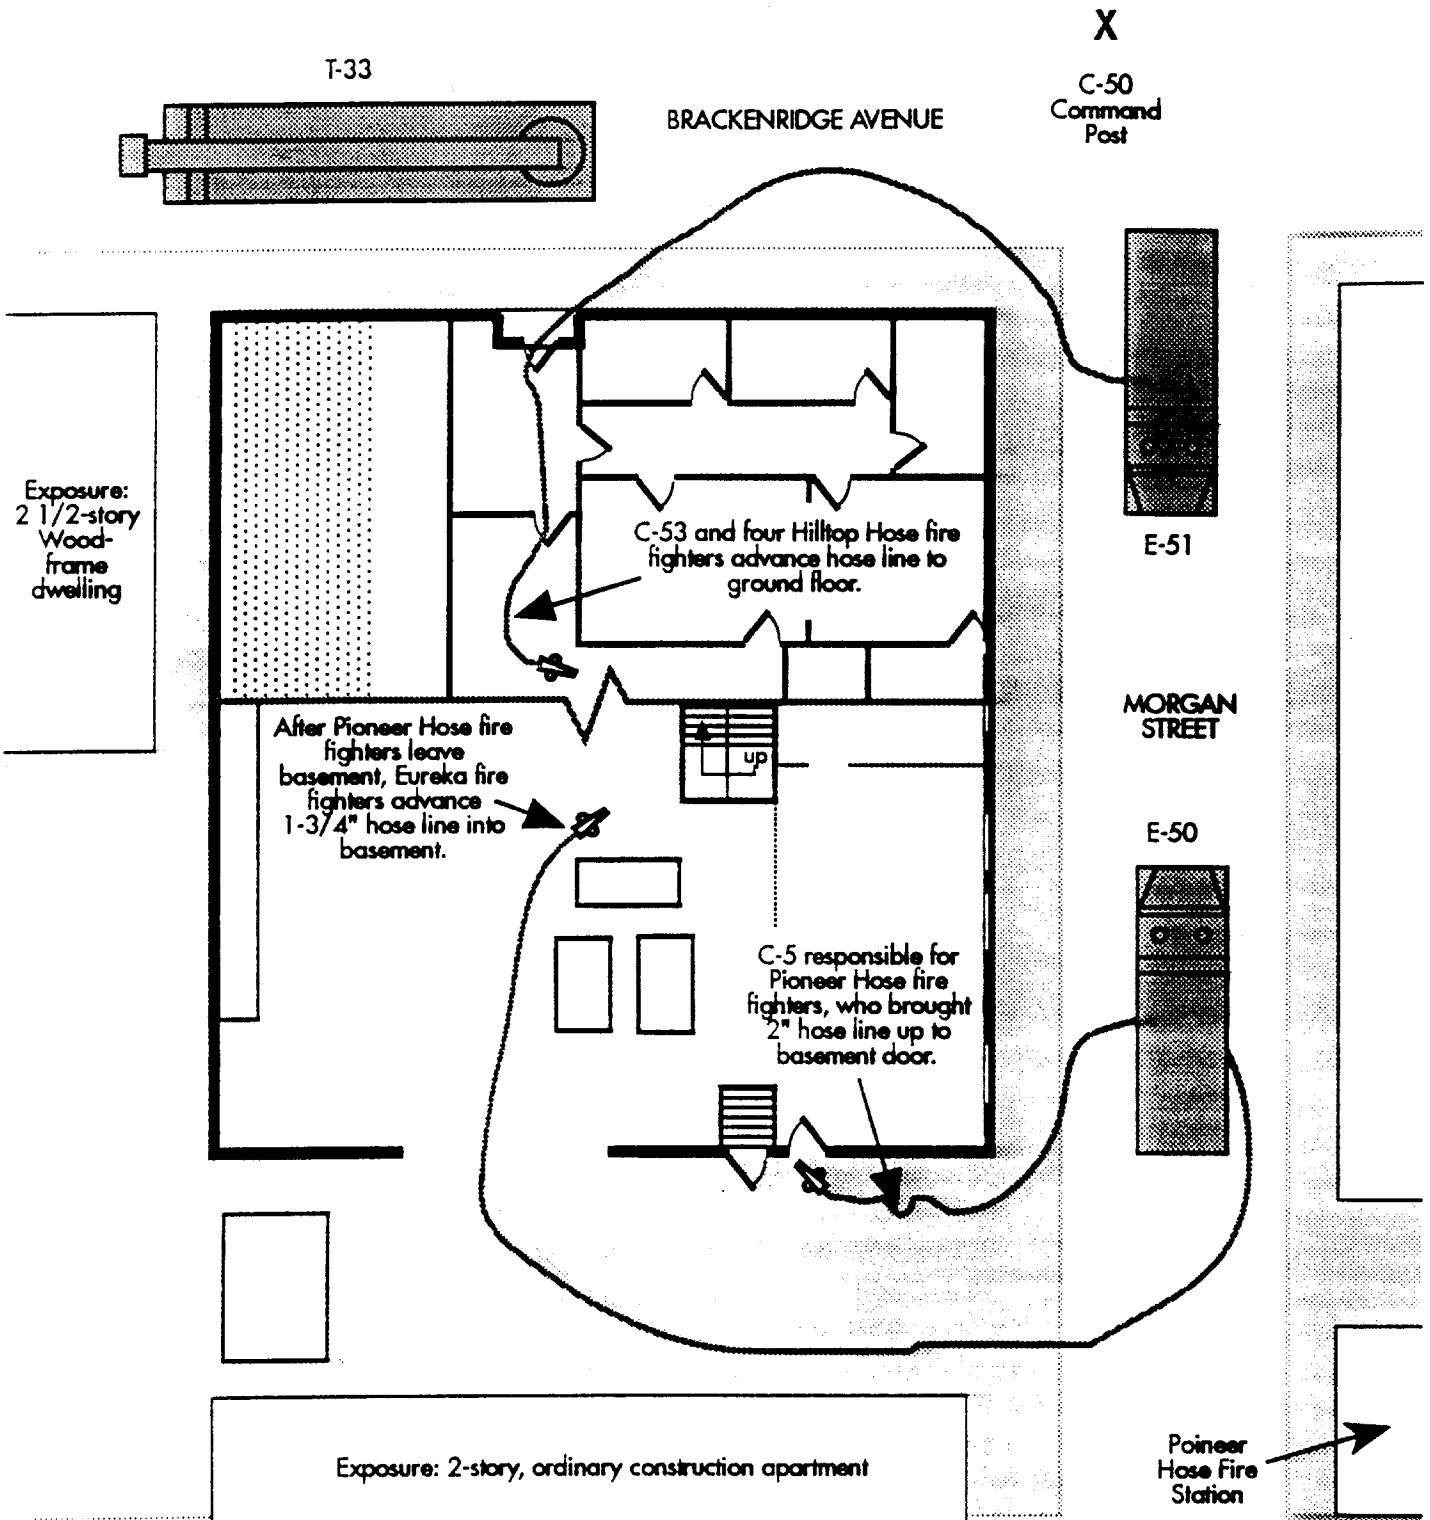
**BASEMENT AND FIRST FLOOR
FIRE SUPPRESSION CREW LOCATIONS**
Figure 2

Pioneer Hose Company was dispatched to this fire at 5:46 a.m. The Pioneer Hose Company fire chief (C-50) responded directly to the scene, which was almost directly across the street from the Pioneer Hose Company fire station. (See *Figure 2*.) The chief found light smoke surrounding the building, and requested assistance from Hilltop Hose Company at 5:48 a.m. Because the fire was in his district, C-50 automatically became the incident commander, and responding units reported to him as they arrived.

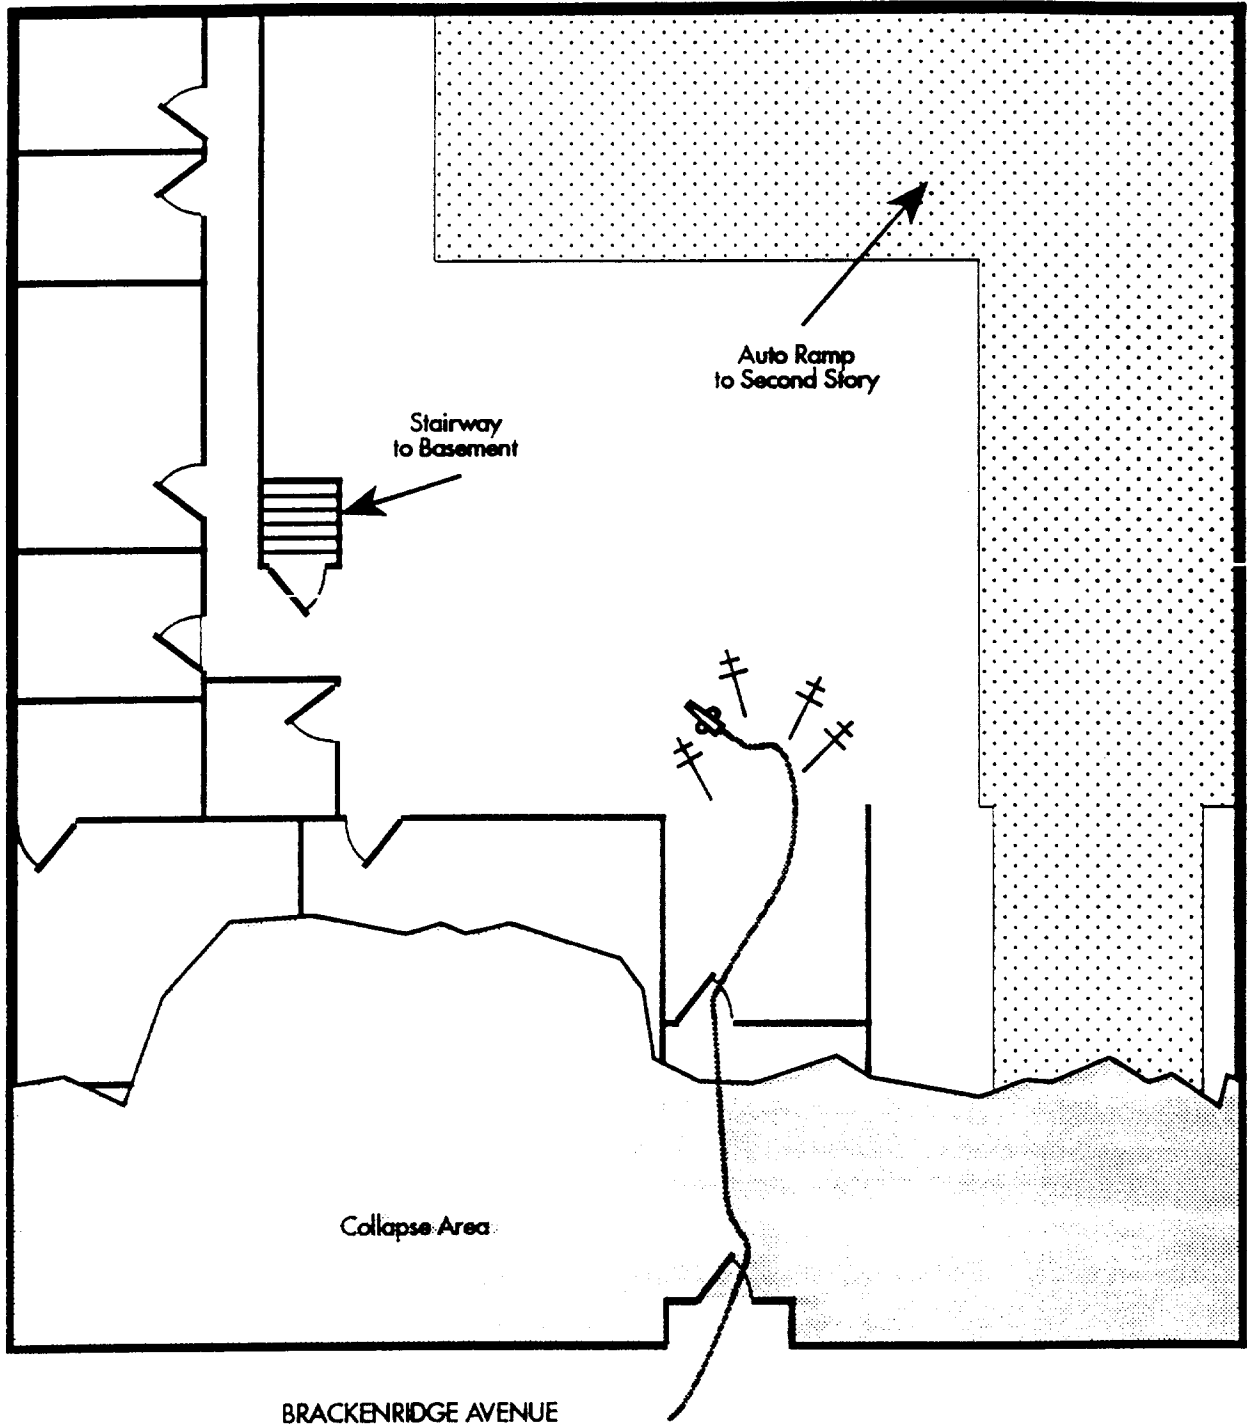
**WEST INTERIOR SERVICES
COLLAPSE AREA - FIRST FLOOR
Figure 3**

As C-53 was stepping out of the building, a Pioneer Hose Company fire fighter who was previously venting windows along Morgan Street stepped into the building. Almost immediately after this fire fighter entered the building, the floor directly inside the first-story entrance door began to fall in. (See *Figure 3*.) Fire fighters outside saw what was happening, and as the fire fighter just inside began to jump out, they reached for him and pulled him to safety. The four Hilltop fire fighters in position on the first story were trapped, however. Moments after the concrete floor fell in, a huge blue fireball erupted out of the resulting opening and filled the first and second stories with fire.

During the initial collapse, the section of the first-story floor assembly in the area of the finishing room fell into the basement. This collapse area extended from the building's front foundation wall to the first line of girders (a distance of approximately 15 ft). The falling floor assembly apparently ruptured many of the containers of flammable liquids stored in the basement, and the leaking material was ignited, forming the huge fireball that filled the first and second stories with fire. It was this fireball that engulfed and killed the fire fighters before they had time to react.

The initial collapse of the first-story floor assembly appears to be the function of both fire exposure and corrosion. Like all the beams in the structure, the beams above the finishing room were not protected with any

type of fire-rated material. Since the area of fire origin was considered to be the basement finishing room, the beams above this room were exposed to the fire for the longest period of time and would have experienced the greatest reduction in strength due to heat. At least one beam, and reportedly others, above the room of origin were corroded to such a degree that the cross-sectional area of the beam was substantially reduced, also reducing the strength of the beam. It appears that the combined reductions in beam strength due to corrosion and fire impingement allowed the failure to start in the area above the basement finishing room.

Some time after the initial collapse, the single column in the basement supporting the line of girders closest to Brackenridge Avenue failed, allowing these girders to drop several feet. The girder movement allowed any beams remaining in place between the foundation wall and the first line of girders to fall into the basement. In addition, beams between the first and second rows of basement girders and in the second-story floor assembly also pulled free of their mountings, allowing these beams to fall into the basement, too.

Except for a few beams above the finishing room, the collapsed beams in the first-story floor assembly area remained attached to the foundation wall at one end and were pulled off the girder at the other end. It appeared that the beams were able to pull free readily because they were not welded, bolted, pinned, or otherwise held to the girder. This type of failure is not common because small beams are usually permanently fixed to the larger structural members by some positive means. As a result of the beam/girder connections, the entire first-story floor assembly up to the first line of

girders and even part of the first-story floor assembly between the first and second lines of girders were able to fall into the basement.
