Summary Investigation Report

Annandale Village Fire
Gwinnett County, Georgia
August 31, 1983

Tom Timoney
Fire Protection Specialist
National Fire Protection Association

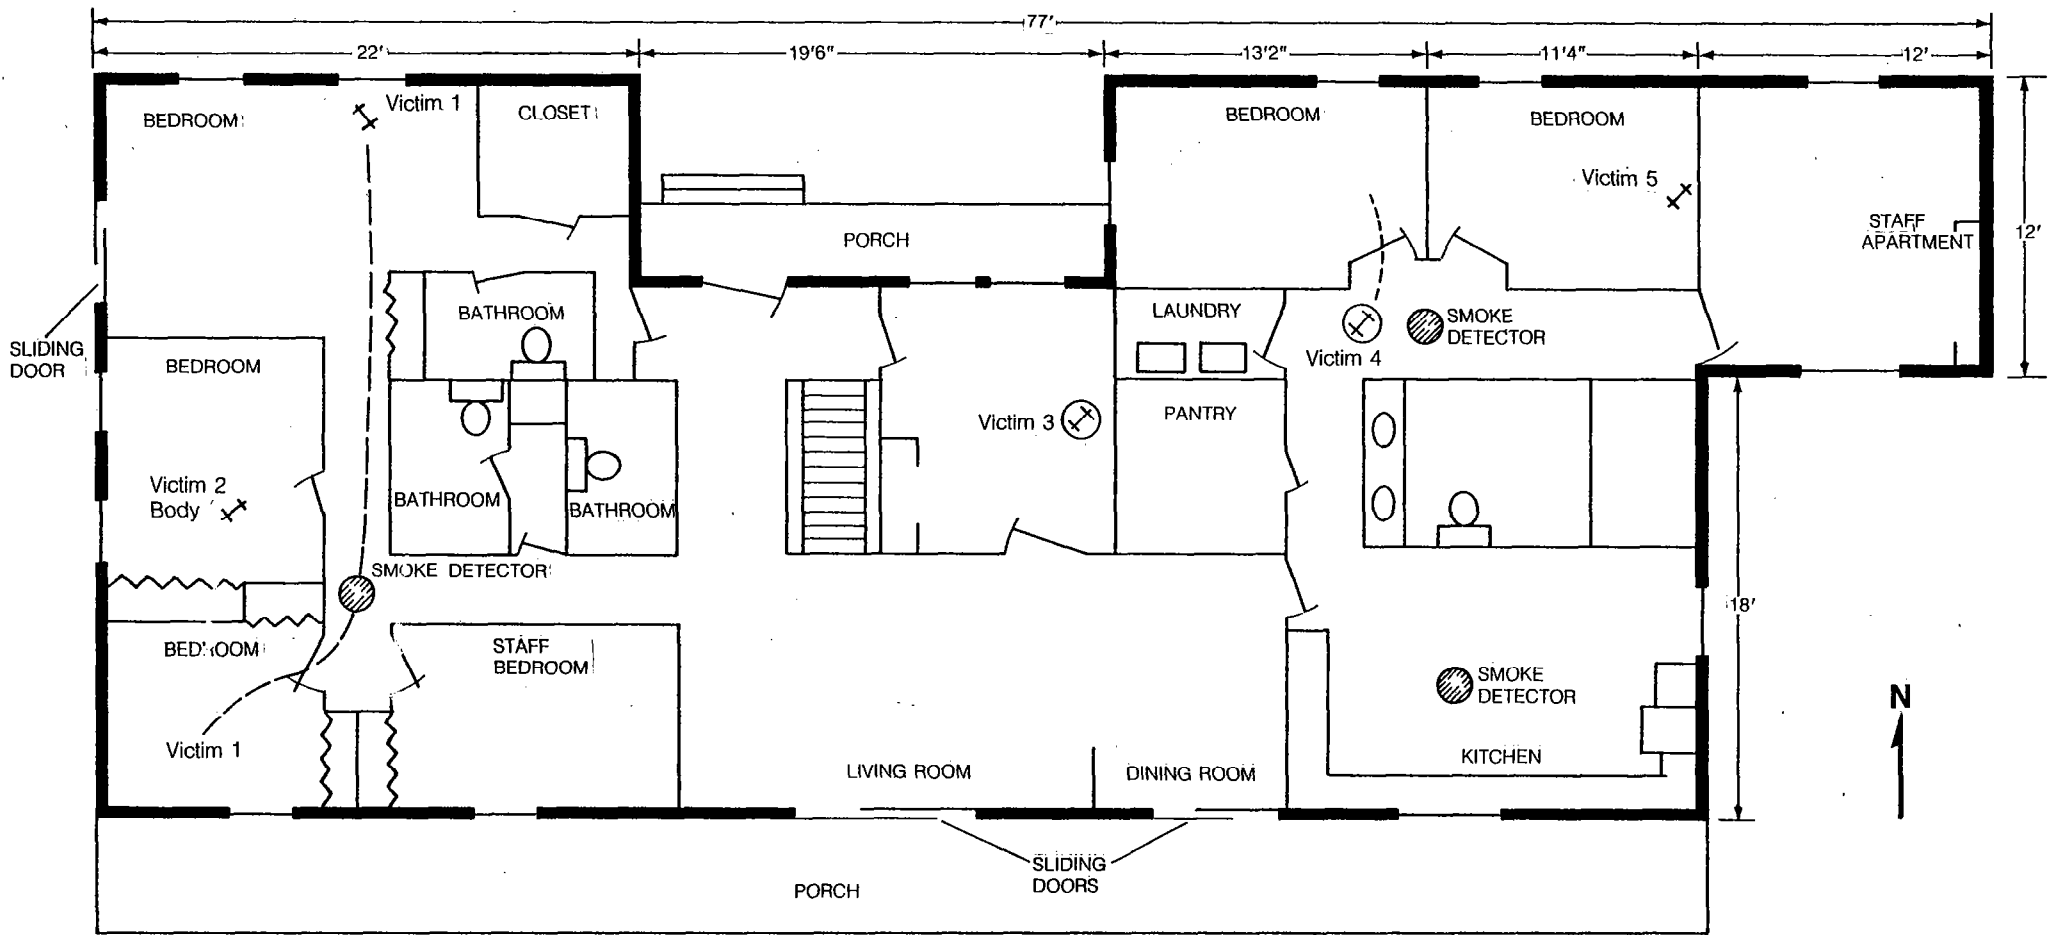
FIGURE 2

Eight residents unable to egress the building died as a result of the fire. The victims ranged in age from 25 to 54 years old. Four of the victims were men and four were women. The four women all occupied single bedrooms on the upper level of the building. One of the women who slept in the bedroom on the northeast corner of the building was found in bed by fire fighters during search and rescue operations. A second female victim in an adjacent bedroom was in the rubble of the lower level following the building collapse. It is believed she was overcome while attempting to egress through the corridor outside her room. The third female victim was found in her bedroom on the west side of the upper level. Little is known about any actions she

may have taken during the fire. The fourth female victim slept in the bedroom on the southwest corner of the upper level. Her body was found in the bedroom on the northwest corner of the upper level. It is believed she either became disoriented attempting to egress through the corridor to the main entrance or she was attempting to exit through the sliding glass doors on the west wall of the northwest corner bedroom where her body was found. The fifth victim from the upper level slept in the center bedroom located adjacent to the open stairway, his body was found in the rubble of the lower level following building collapse. Little is known about any actions he may have taken in attempting to egress, however, his roommate was the survivor rescued by the staff member who reentered the building following his alerting of other staff members to the fire.

Annandale Village
Suwanee, Georgia
Upper Floor

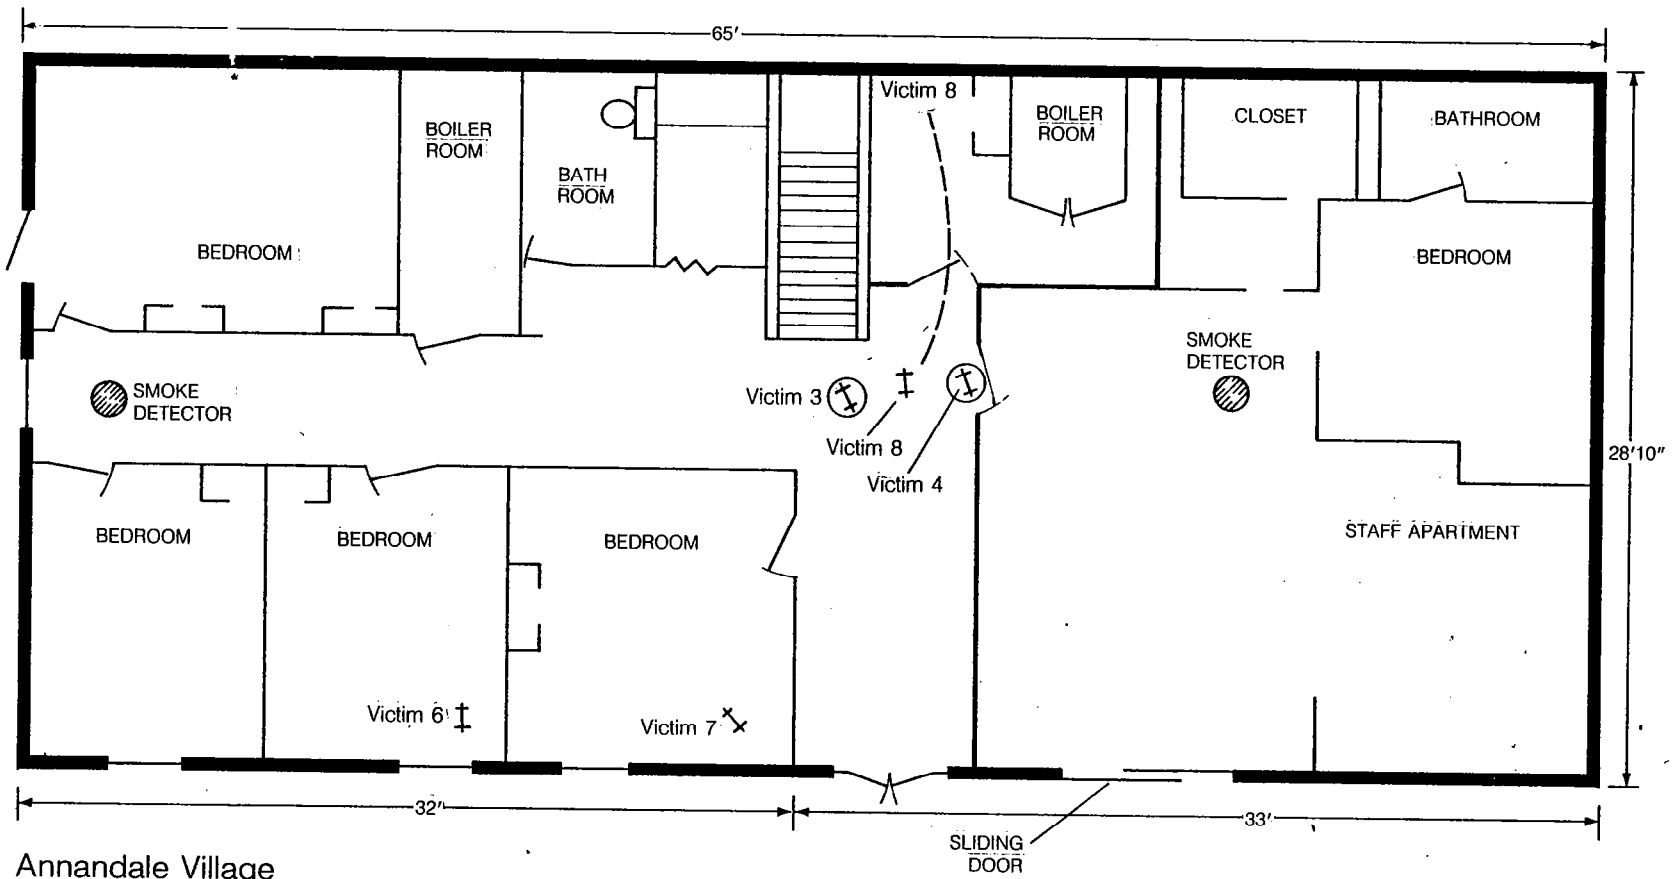
FIGURE 1

The building was equipped with 5 single station smoke detectors powered by the building's electrical system and located as shown in Figure 1. There was no documented detector maintenance or testing program and none was described during staff interviews.

While five single station smoke detectors were installed in the building, two on the lower level and three on the upper level, the fire was already well developed when a detector activated and awoke the staff member sleeping in an upper level rear bedroom. Identification of which detector awoke the staff member was never established. In addition, it was never established whether any other detector activated, and if so whether the activation of any of these detectors alerted any of the residents to the fire.
