AUTO DEALERSHIP

Hackensack, NJ

SUMMARY INVESTIGATION REPORT

Five Fire Fighter Fatalities
Hackensack, New Jersey
July 1, 1988

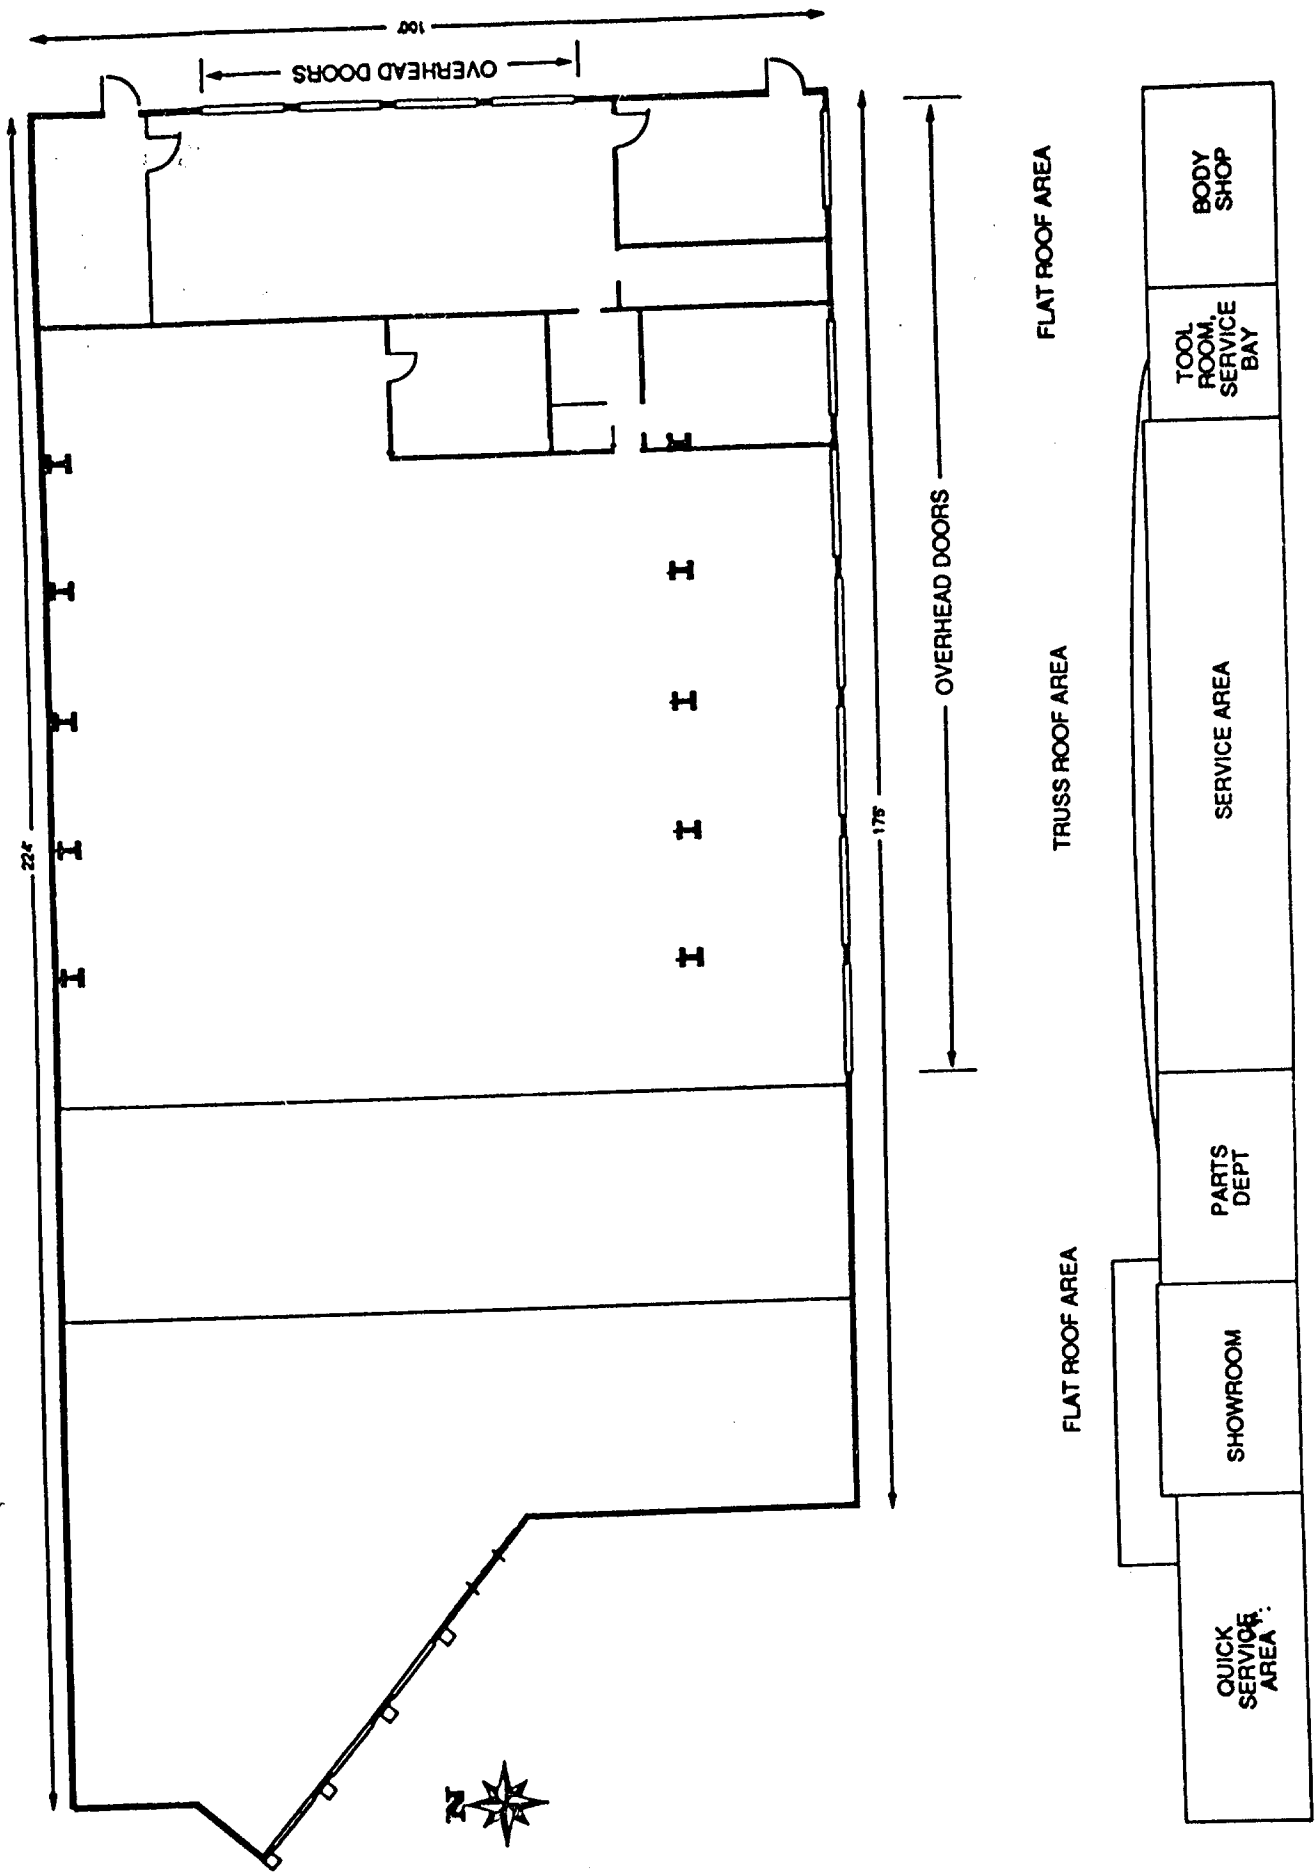
FIGURE 1: TOP VIEW AND SOUTH ELEVATION

The new car showroom and a quick service area were arranged along the front, western portion of the building, closest to River Street. New cars were also displayed on the exterior of the building between the showroom and the street. An approximately 30-foot wide service road provided access to the remaining sides of the building. The auto service area was located in the center portion of the building accessible from the north and south sides of the building. The body shop was located at the east end of the building. (See Figure 1.)
