**BEAUMONT NURSING HOME**

# **FIRE INVESTIGATIONS**

Investigation Report

**Beaumont Nursing Home**  
Little Rock, Arkansas  
January 12, 1984

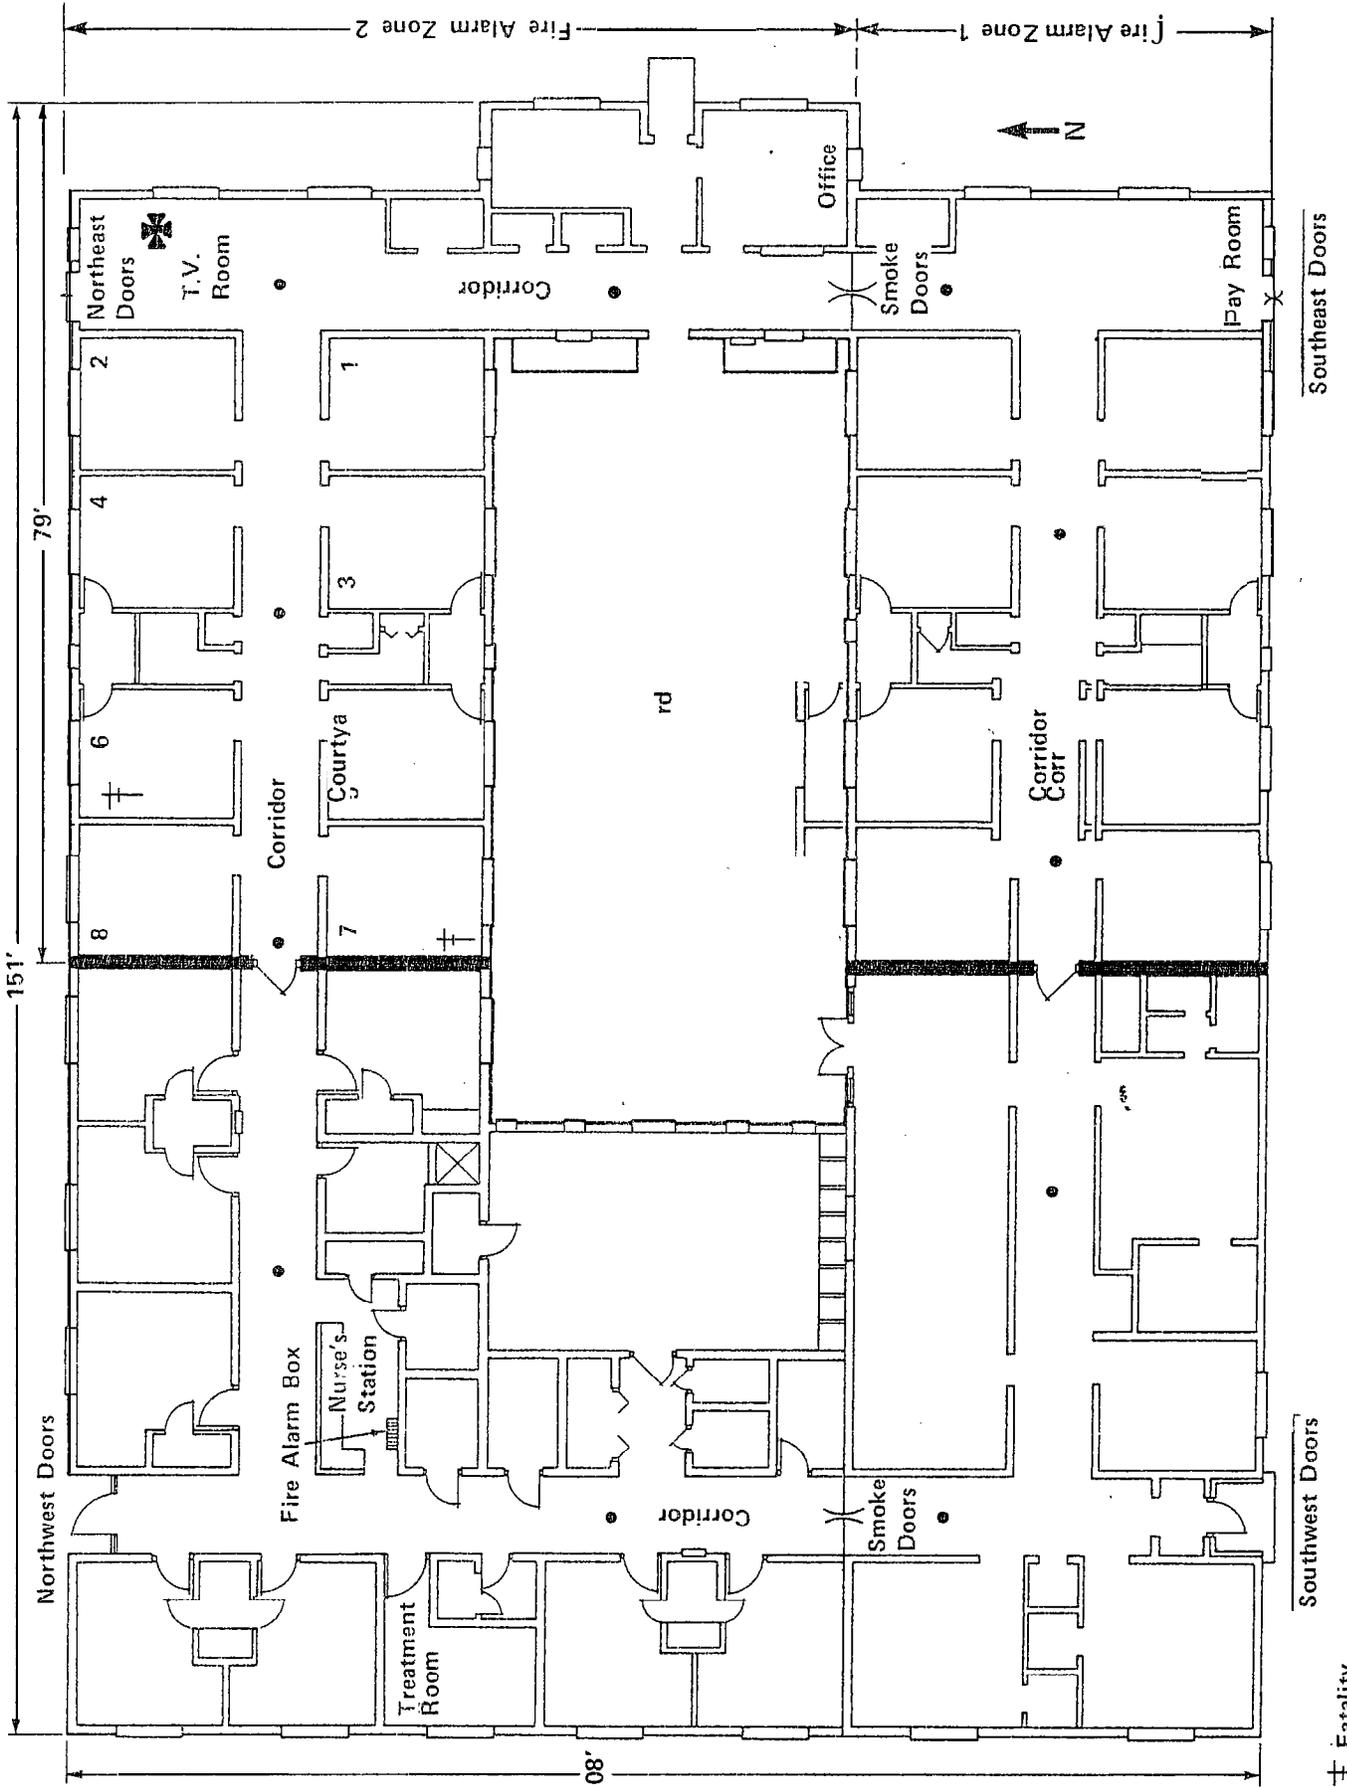
Figure 1

The Beaumont Nursing Home, located in Little Rock, Arkansas, was a 1-story, 61-bed, rectangular facility with an interior courtyard (see Figure 1). The approximate overall dimensions of the facility were 151 feet by 108 feet. A 4-hour fire wall with two corridor openings protected by 2-hour fire-rated doors separated the two "U" shaped sections of the building. A total of six exits were provided at the nursing home. Four of the exits opened directly to the outside and were located at each corner of the building on the north and south sides. The remaining exits were provided by the two fire-rated doors protecting the corridor openings in the 4-hour fire wall creating two horizontal exits from each section of the building.

A "T.V. room" was located in the exit access corridor in the northeast corner of the building. This section of the east corridor widened from 7 feet to a width of 12 feet. An upholstered recliner, a couch, and two end tables with lamps were arranged along the east wall of the corridor facing a television on the west wall. Fire department investigators identified the cushioning material in the recliner and the couch to be urethane foam. From the main nurse's station, 88 feet away, full view of the "T.V. room" was obstructed.

All the components in the fire alarm system were connected to a three-zone fire alarm annunciator panel located at the main nurses' station (see Figure 1). Zone one included all the smoke detectors and pull stations in the south half of the building, while zone two included all the smoke detectors and pull stations in the north half of the building. Zone three monitored water flow in the automatic sprinkler system.
