HIGH-RISE APARTMENT FIRE

Manhattan, NY
January 11, 1988

NATIONAL FIRE PROTECTION ASSOCIATION

Investigation Report
Apartment High-Rise Fire
Manhattan, New York
January 11, 1988

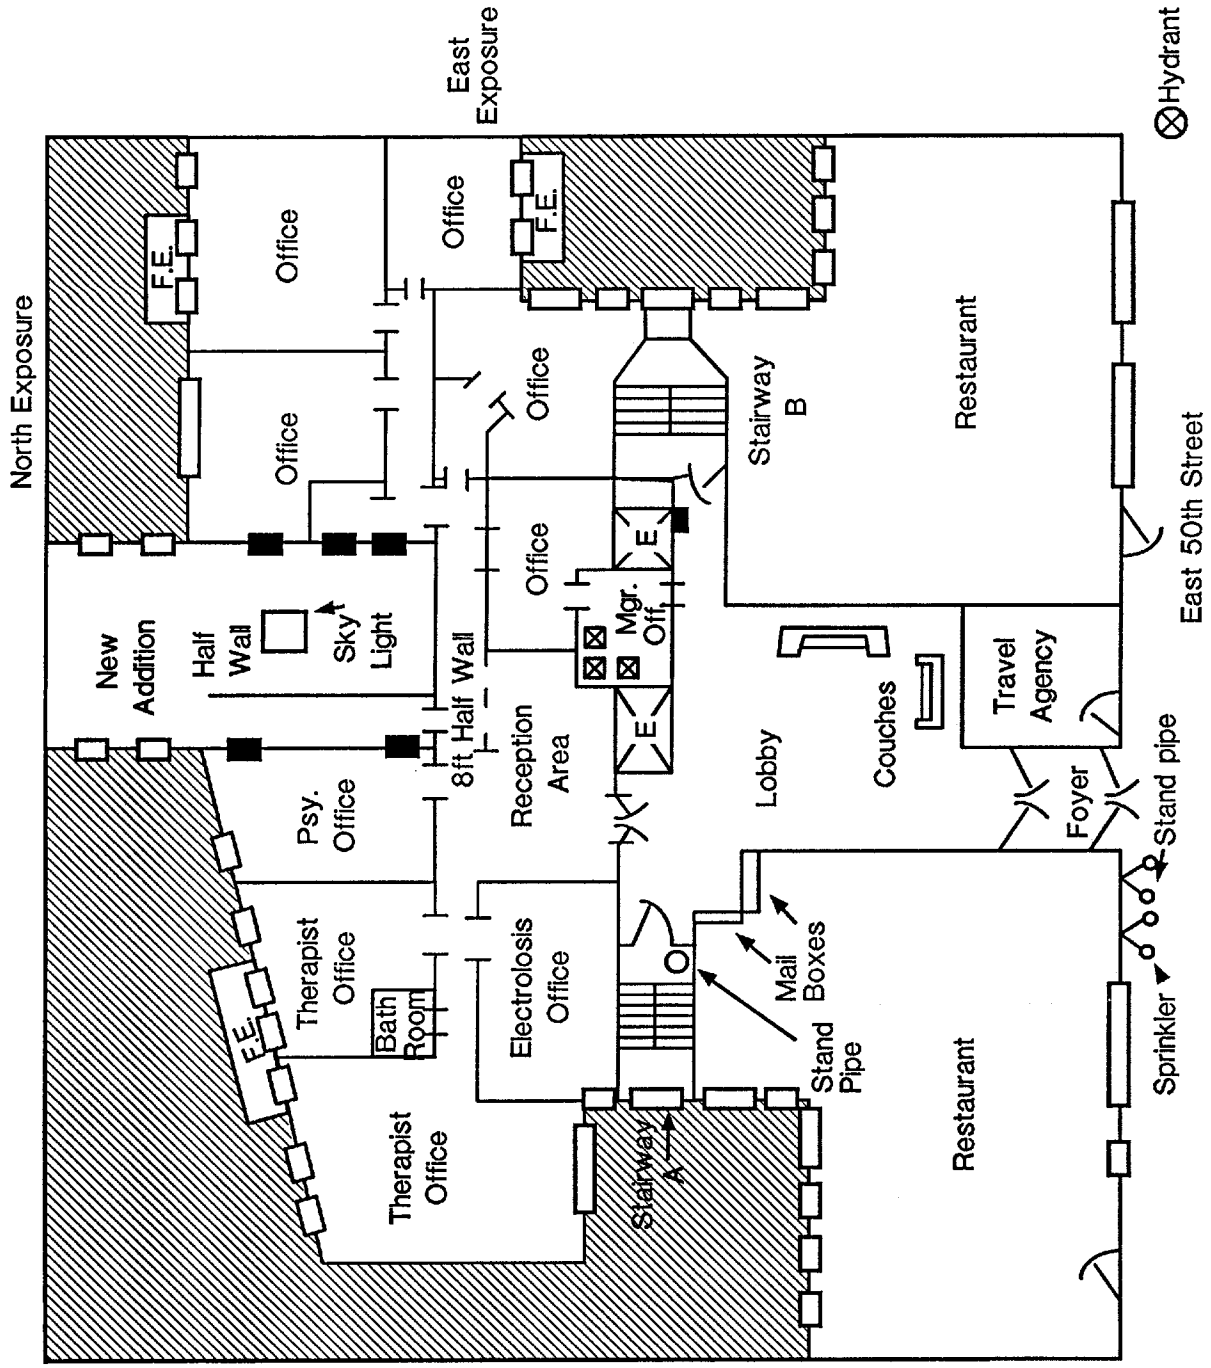
Figure 1: First Floor Plan at Time of Fire

Significant renovations of the building's first floor had also occurred. The original masonry load bearing walls were retained to ensure structural integrity but many new nonload bearing interior partitions were added. The new walls establishing separate tenant spaces were constructed with gypsum board; some walls had wood studs and others had metal studs. Most of the original masonry walls on the first floor were also covered with gypsum board. The gypsum board-faced walls for the offices and reception area in the rear of the first floor were then covered with plywood paneling. A set of lockable glass doors with aluminum frames separated the rear office area from the front lobby.

As a result of the building modifications, Stairways A and B were the only means of egress for occupants of apartments not equipped with fire escapes. Both interior stairways had an access door to the roof and self-closing metal doors separating each stairway from the occupied area on every floor. Stairway B discharged into a small corridor that led into the first floor lobby and Stairway A discharged into the same lobby. A small foyer was the only exit discharge from this lobby.

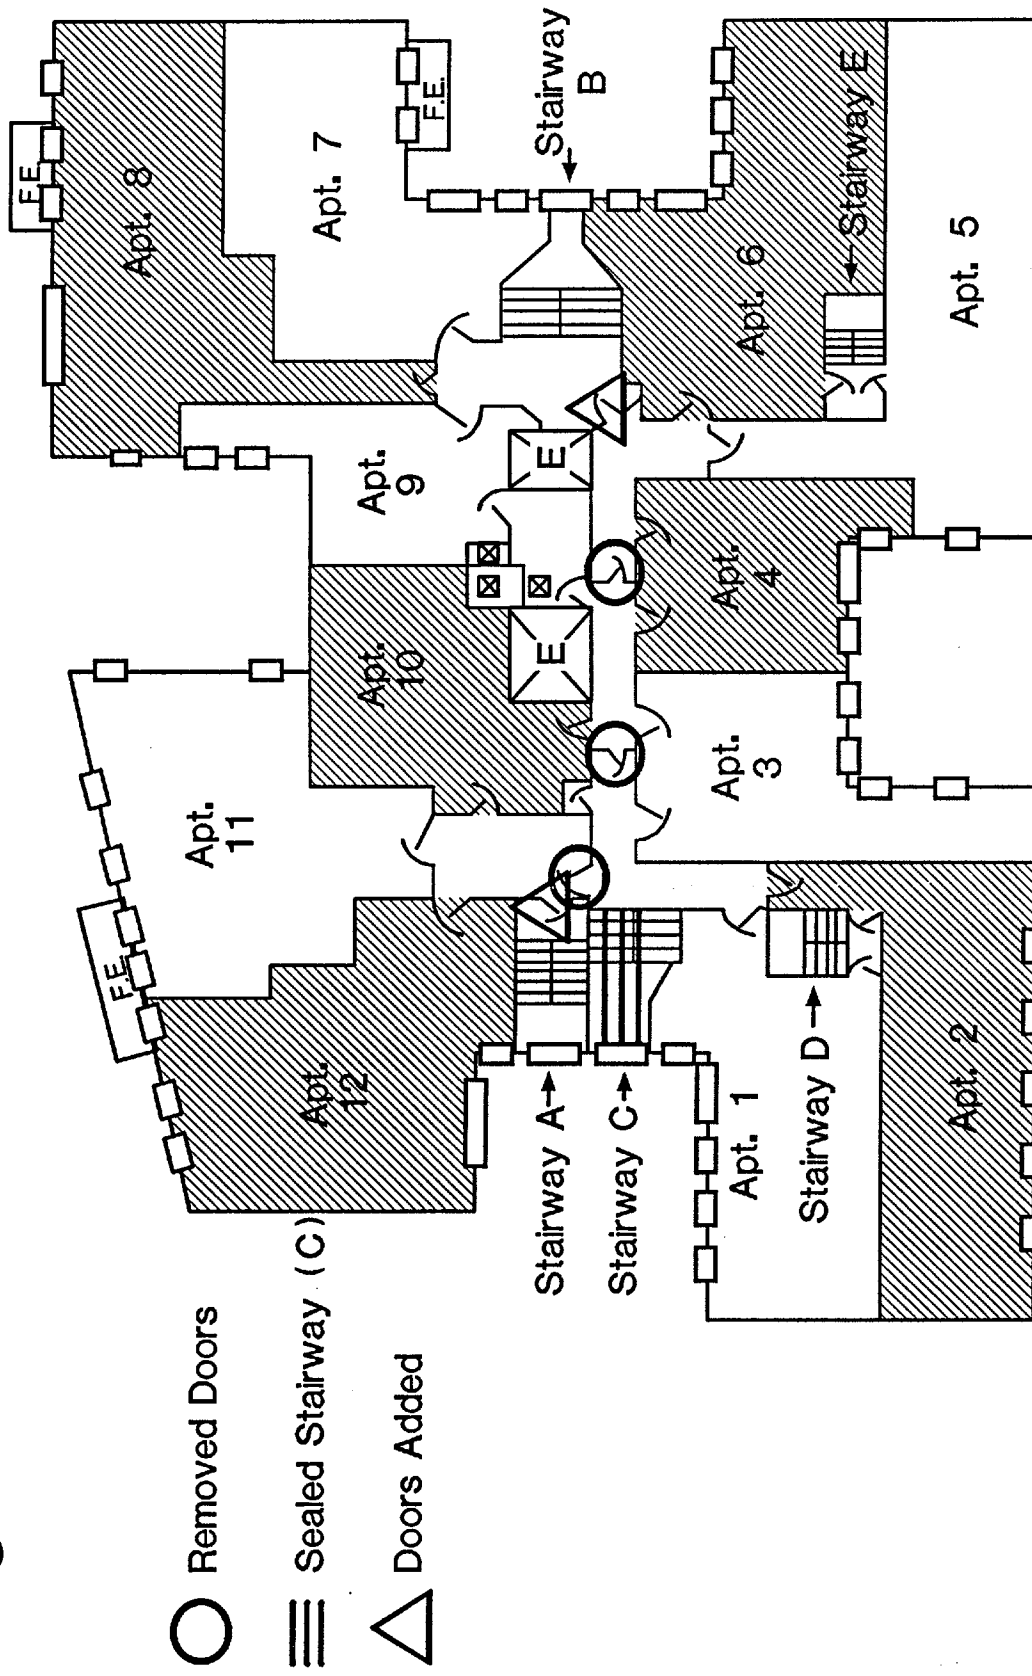
Figure 2: Door Placement Floors 2-9

During building alterations, many changes were made to the means of egress. Doors that divided the corridors on floors two through ten were removed and new doors were installed closer to Stairways A and B. The change of exit door locations resulted in most apartments opening onto a common corridor and eliminated the separation between the access to the enclosed stairways from Apartments 3 and 4 on all floors. Stairway C had been sealed with masonry and covered with plaster to match the finish of other interior

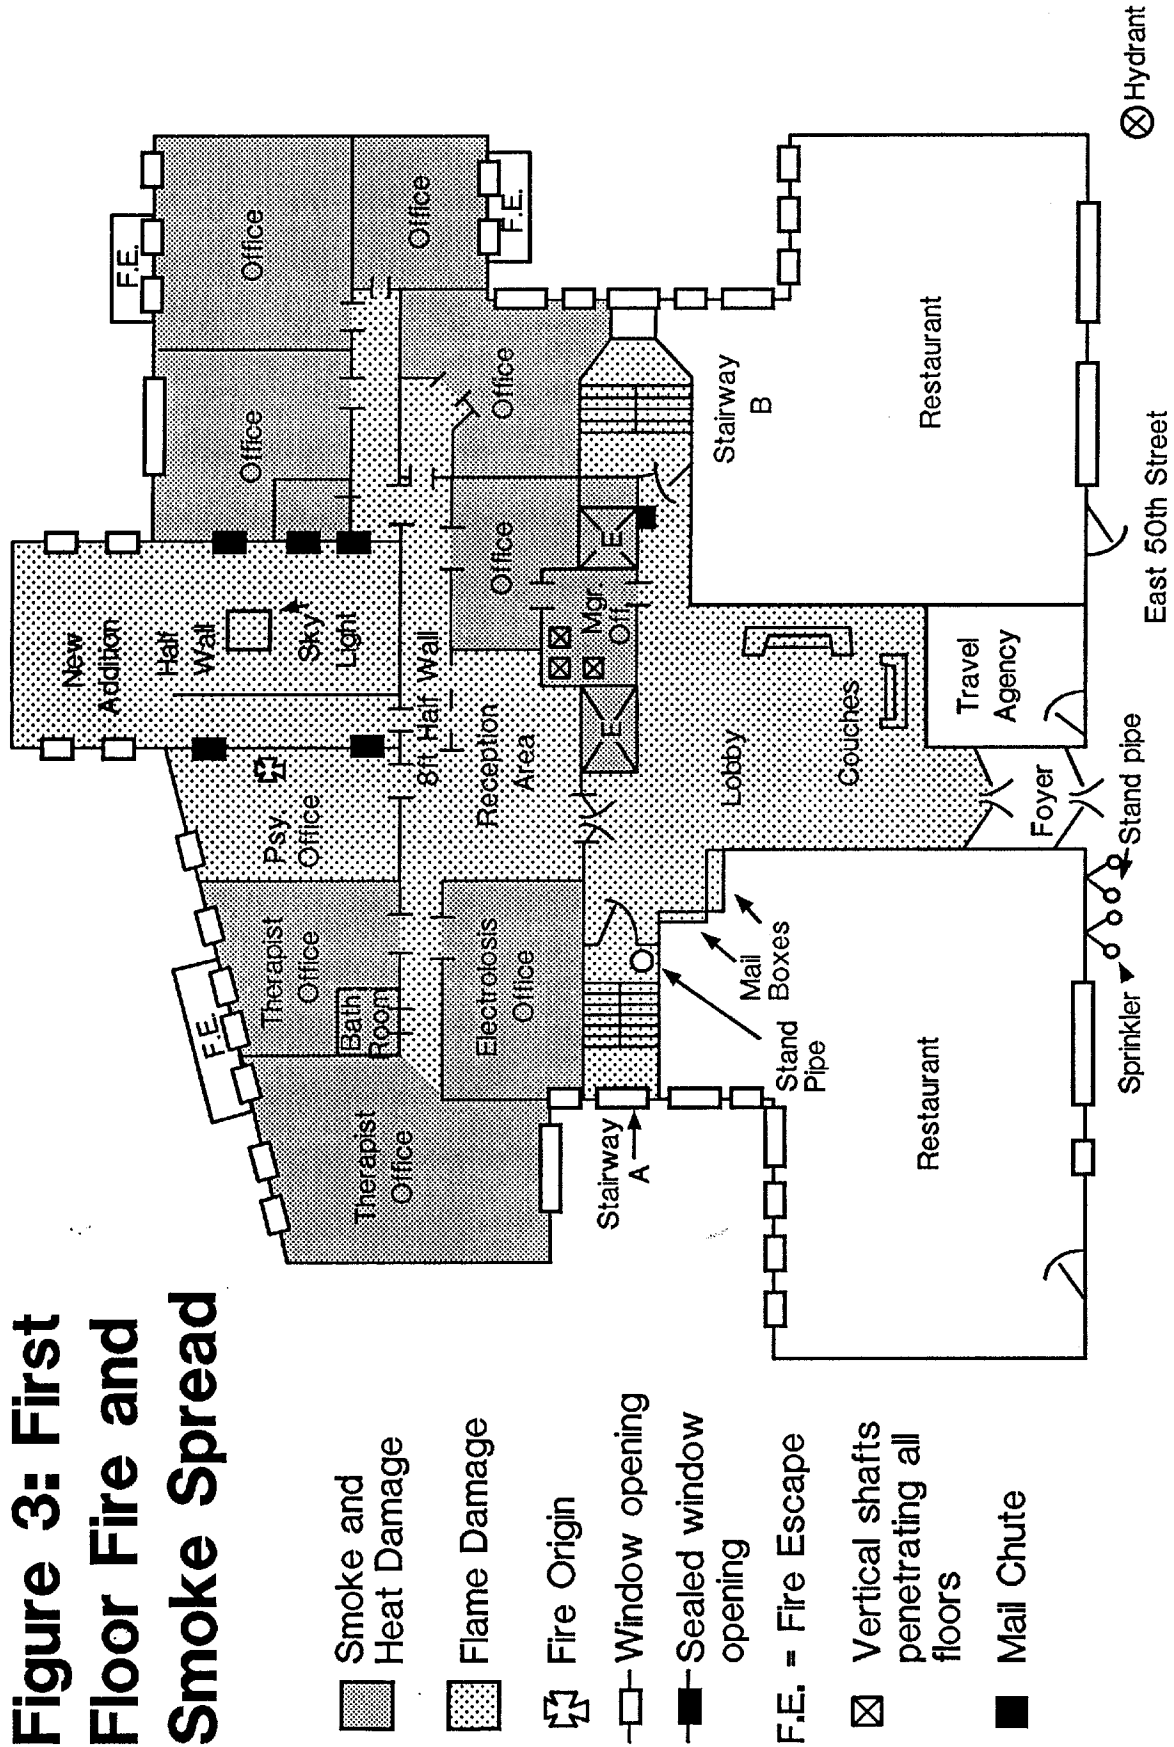
Figure 3: First Floor Fire and Smoke Spread

Extensive fire damage occurred on the first floor (see Figure 3). Two offices, the reception area, and front lobby were gutted by fire. Nine other offices at the rear of the first floor received varying degrees of flame, heat, and smoke damage. The two restaurants were not damaged during this incident and were able to resume business the next day.

Heavy smoke stains coated all of the interior surfaces of Stairway A. In addition, peeling paint and other evidence indicates that flames impinged on walls enclosing the first floor landing and on the stairway walls between the first and second floors.

Like Stairway A, Stairway B had heavy smoke stains coating its interior surfaces. Floors two through ten had smoke damage in the central corridor and the most severe smoke damage occurred on floors nine and ten.
