NURSING HOME FIRE

Norfolk, VA

October 5, 1989

**FINAL FIRE INVESTIGATION REPORT
NURSING HOME FIRE
NORFOLK, VIRGINIA
October 5, 1989
12 Fatalities**

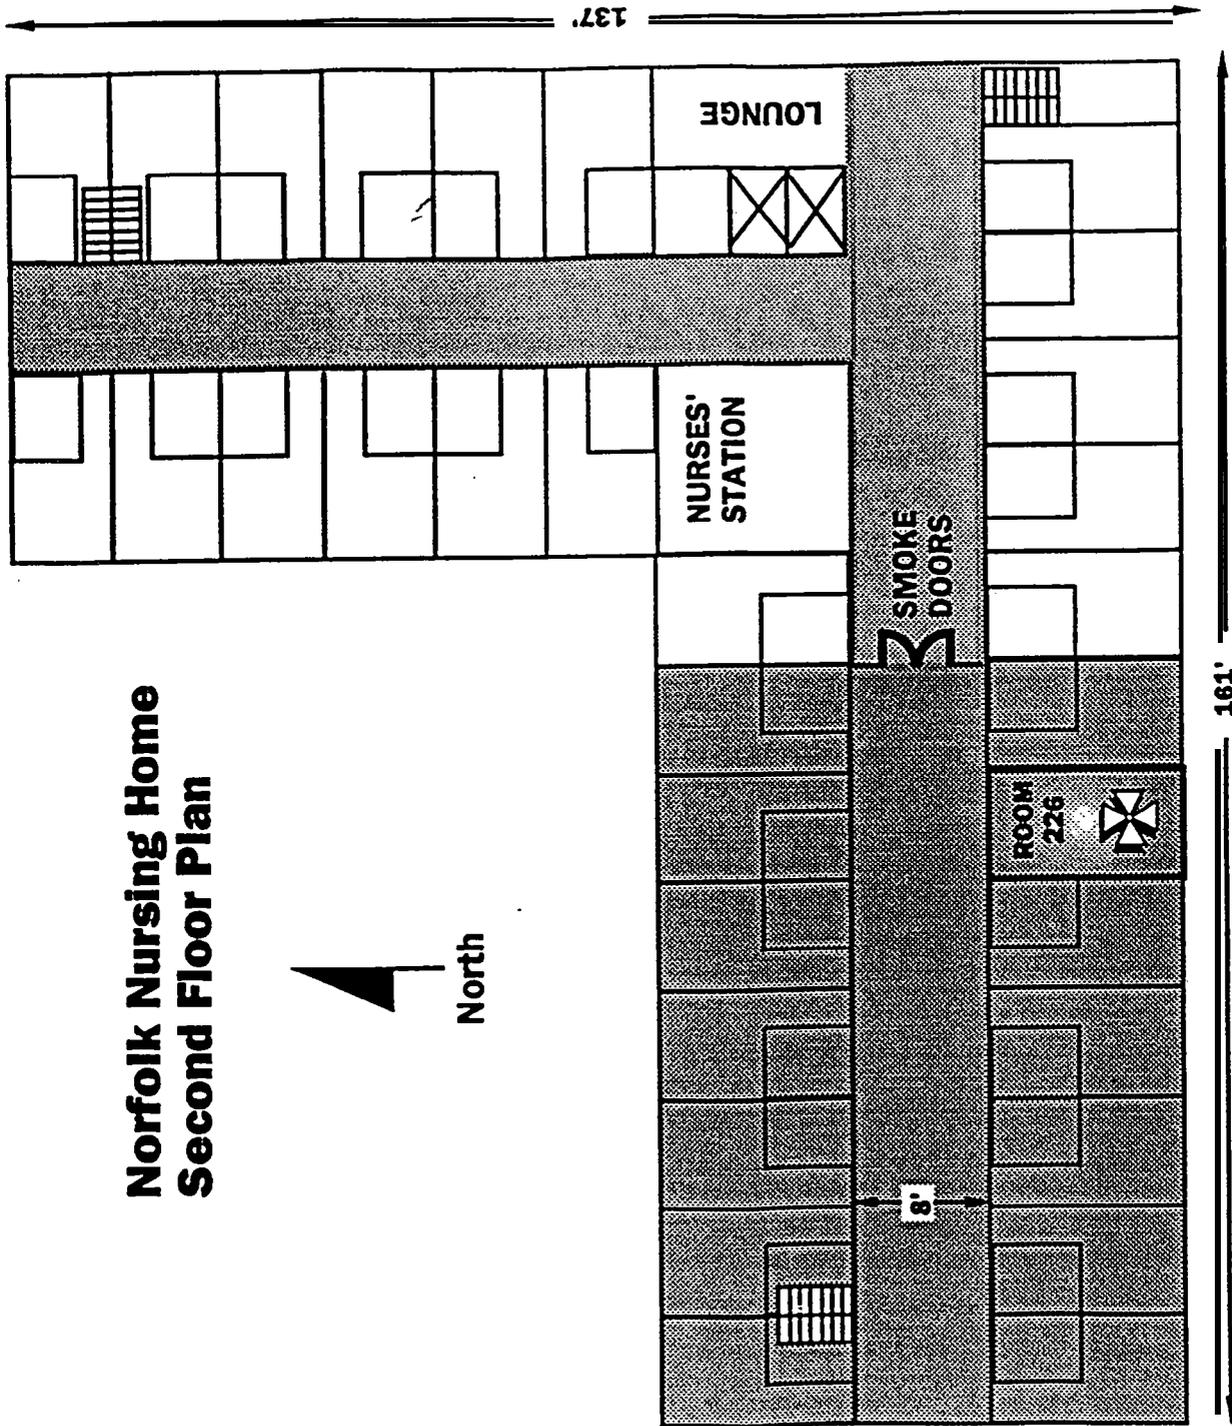
Norfolk Nursing Home Second Floor Plan

Each floor of the building was divided into two separate smoke zones utilizing an interior partition and smoke barrier doors (see diagram). The smoke barrier doors, positioned in the exit access corridor, were held in the open position by magnetic hold-open devices; a component of the fire alarm system (see later description). Although a fire resistive barrier was provided above the smoke barrier doors to fill the void to the floor deck above, the partition did not extend above the suspended ceiling in adjacent patient rooms.
