NURSING HOME FIRE

Woburn, MA

October 30, 1992

FIRE INVESTIGATION REPORT

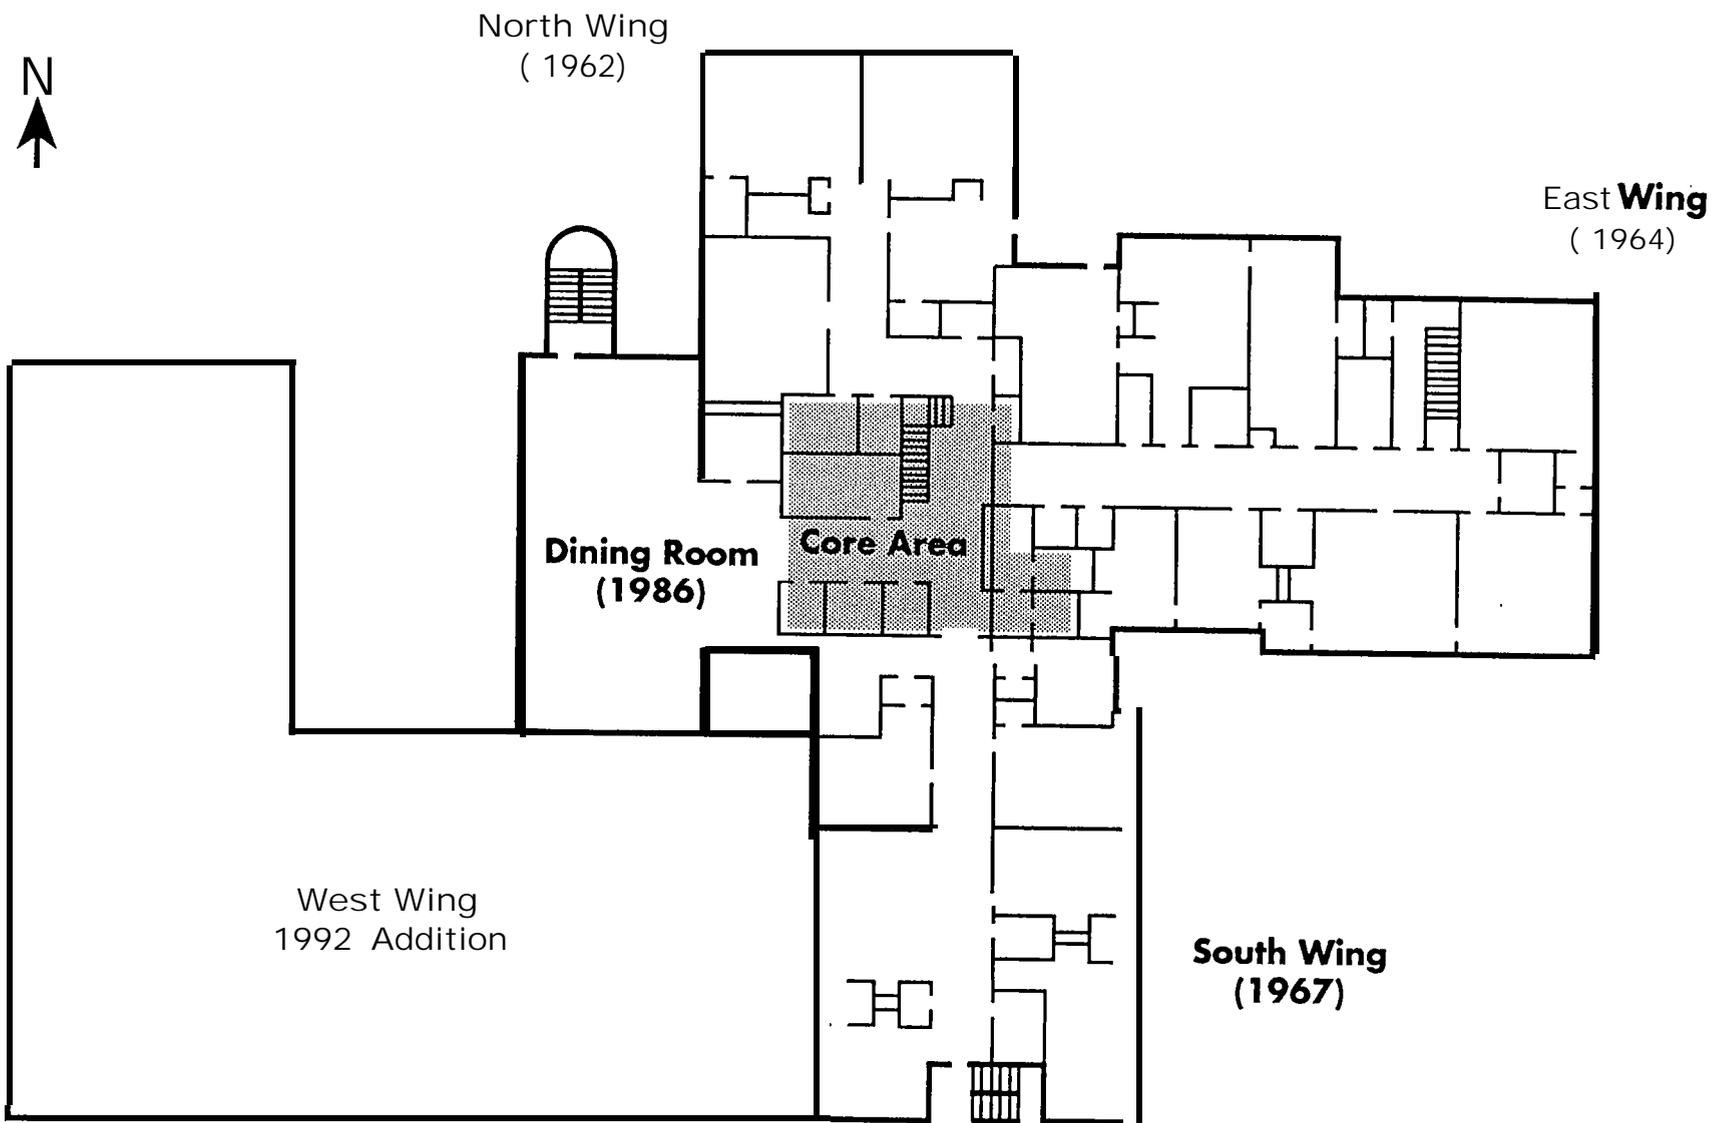
Woburn Nursing Home Plan (Floor **1**)
FIGURE 1

The building housing the Woburn Nursing Center varied in height from two to four stories, and had been expanded through the construction of several additions. (See Figure 1.) The original structure was a two-story-plus-attic, wood-frame dwelling that was converted for use as a nursing home. The first of five additions was constructed in 1962. All of the additions were of light noncombustible construction, and the additions were so located that the original structure was eventually surrounded by new wings. Thus, the old wood-frame structure became the core area for the facility.

At the time of the fire, the patient rooms were located on the wings that were separated from the original structure (now the core area) by slab-to-slab walls. Self-closing fire-rated doors protected the openings in these separation walls. Slab-to-slab walls also separated the patient rooms from the corridor, and all patient rooms had solid-core wood doors. Some patient rooms shared a common bathroom with an adjacent patient room; other patient rooms had common doors connecting the rooms. These common doors enabled people to move from one part of a wing to another part of the same wing without entering the corridor (proving valuable in this incident).

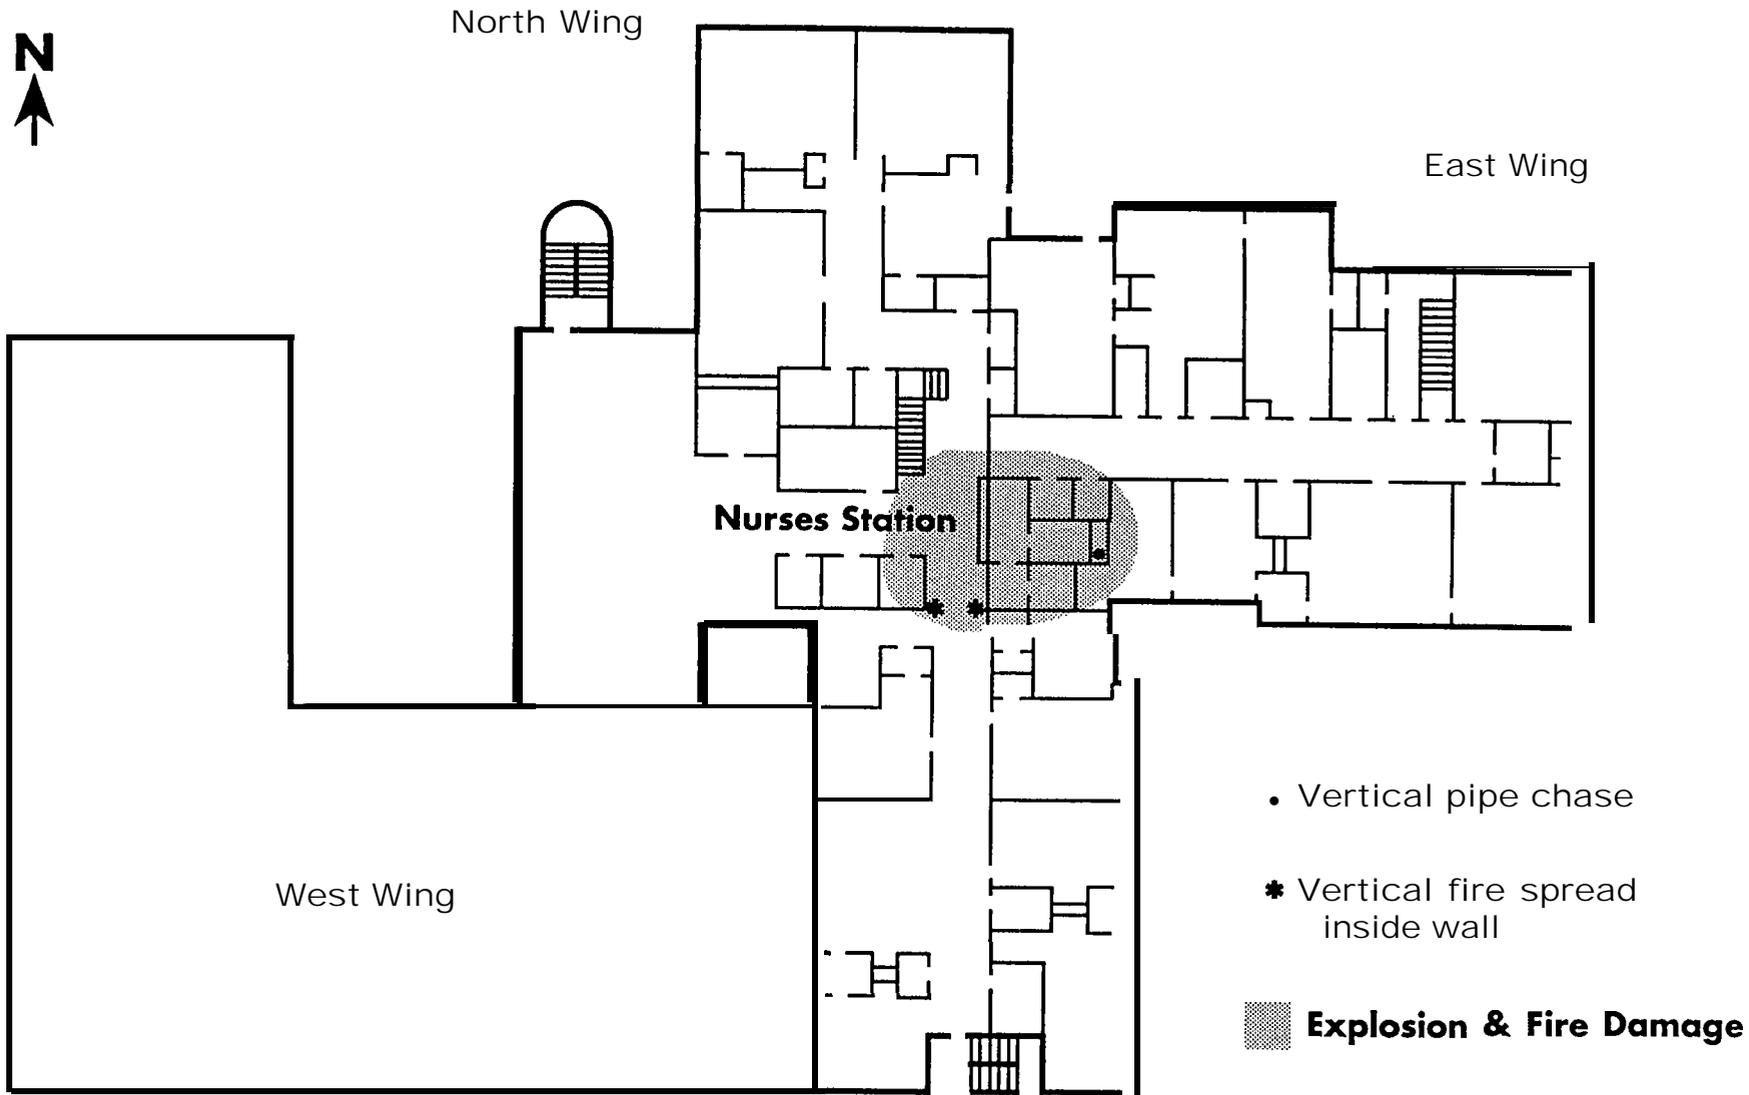
Woburn Nursing Home Plan (Explosion & Fire Damage)
 FIGURE 2

Most of the explosion and fire damage occurred in the wood-frame core area of the building. (See Figure 2.) In this area, similar types of explosion damage occurred from the basement to the third (top) floor, i.e., ceilings collapsed, walls were damaged, and combustible materials inside the wall, ceiling, and roof assemblies were burned. Similar to the explosion damage, most of the fire damage occurred in the core area, and it was severe inside the floor/ceiling assemblies and wall assemblies.

Once the ignition occurred, the explosion and the subsequent fire propagated along the same paths through which the natural gas had previously spread. Over-pressurization during the explosion resulted in the extensive damage to wall and ceiling floor assemblies in the core area. The ignition of the accumulated natural gas in the attic space caused the explosion, blowing a section of roof off the
