# CENTRAL COMMUNITY HOME FIRE

Summary Investigation Report

Central Community Home Fire  
Worcester, Massachusetts  
April 19, 1983

Richard L. Best  
Senior Fire Analysis Specialist  
National Fire Protection Association

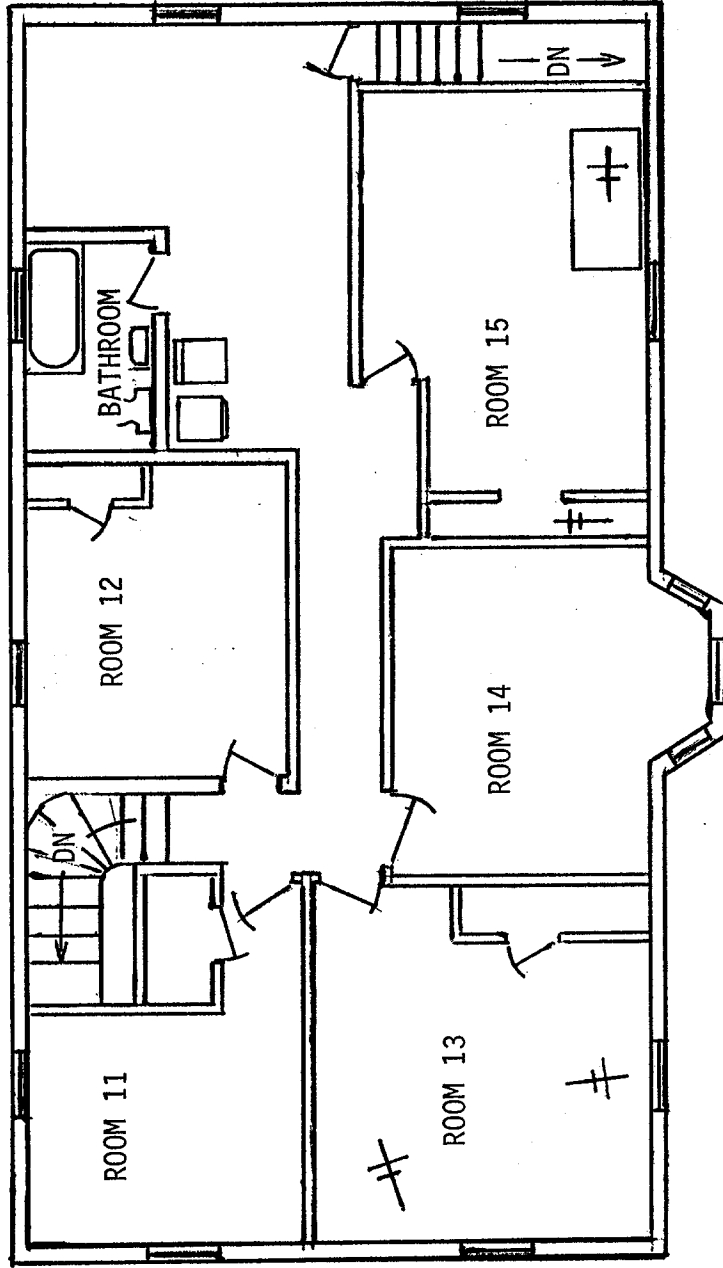
Figure 3.

Fire damage on the third floor was most severe in the corridor in the front (west) two-thirds of the building where the wall paneling burned to within 10 inches of the floor. Doors to the sleeping rooms were burned at the top with many burned more than halfway from the top to the bottom. Smoke and heat marks in all rooms were to within one-and-one-half to two feet from the floor. It appeared that the rear stairway door remained closed for a period of time during the fire and that the main fire exposure to the third floor was by way of the front stairway. A light bulb at the top of the rear stairway was not broken, but part of the plastic smoke detector housing was melted, indicating that temperatures in the rear stairway reached above 475 °F but did not exceed approximately 1,500 °F.
