The Effect of Obstructions on ESFR Sprinkler Performance

Garner A. Palenske
Jensen Hughes, San Diego, CA. USA

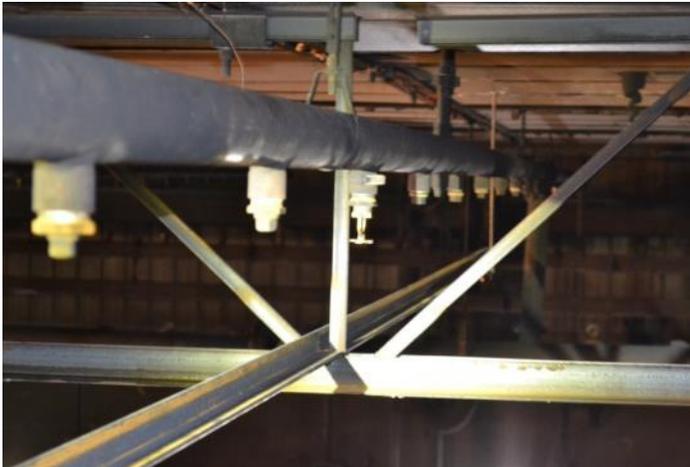
Currently ESFR sprinklers are required to be located a minimum of 12 inches horizontally from the nearest edge of any bottom chord or bar joist. A bridging member of 2 inches or less in width is required to be located a minimum of 24 inches below the elevation of the sprinkler deflector or positioned a minimum of 12 inches horizontally from the sprinkler deflector. The ESFR design standards also limit the height of storage from being within 36 inches of the sprinkler deflector. Figure 1 shows a typical bar joist, sprinkler, and bridging member arrangement.

Figure 1. 22-inch Deep Bar Joist with Bridging Member.

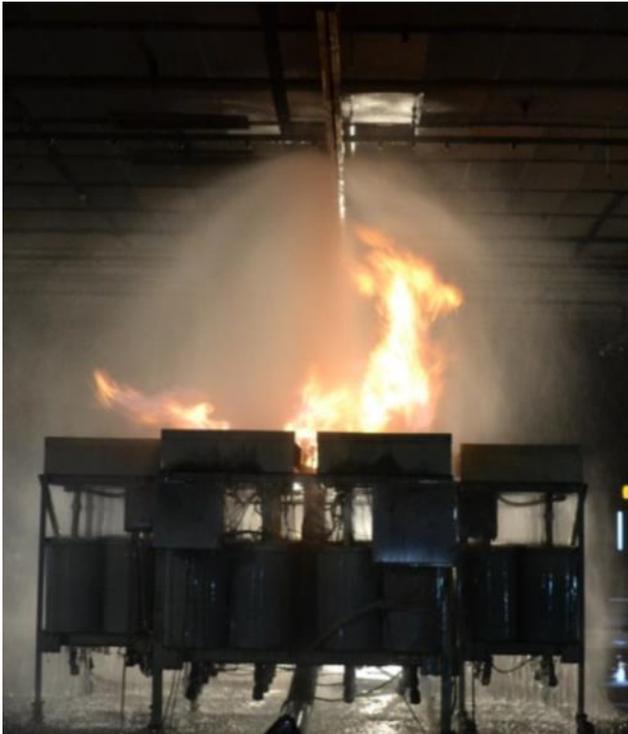
The apparatus was arranged to simulate the planned full-scale fire test configuration. The center of the ADD apparatus was located directly below the sprinkler and the top of the apparatus (representing the top surface of stored commodity) was located 10 feet from the ceiling. The apparatus was calibrated to produce a heat release rate of 2.5 MW, which is the heat release rate expected from a fire occurring within rack storage of cartoned, unexpanded Group A plastic commodity to a height 30 feet. Figure 3 shows the east view of the ADD apparatus during one of the bar joist obstruction tests.

Figure 3. ADD Testing Apparatus With Obstruction.
