COLD STORAGE WAREHOUSE

Madison, WI

May 3, 1991

\$100 Million Fire Destroys Warehouses

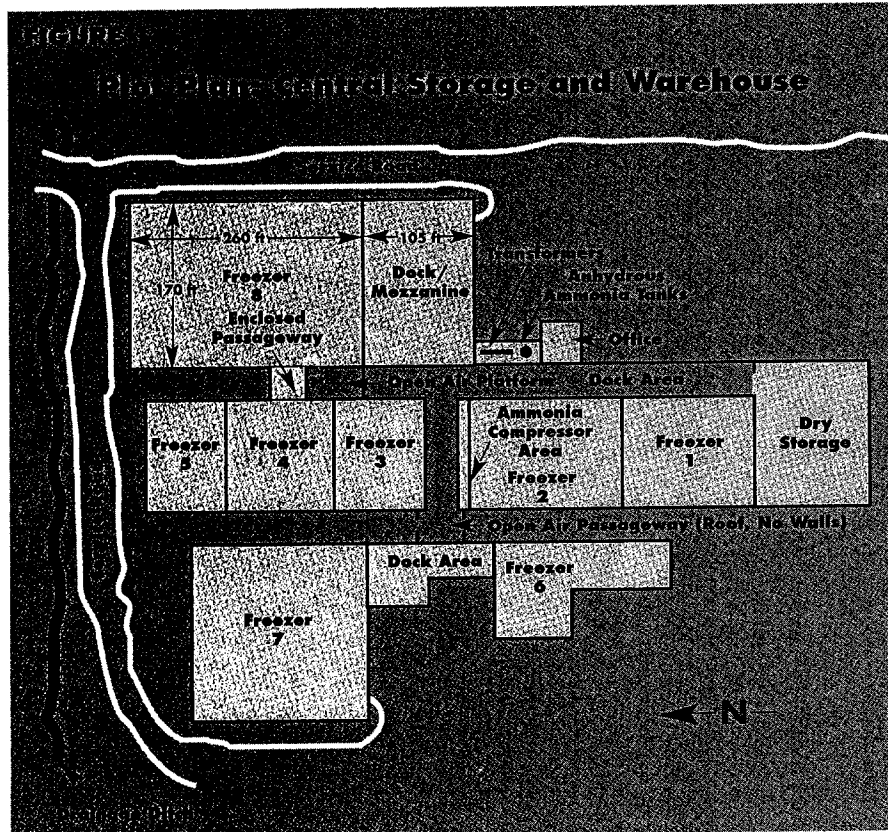
Most of the 13 million pounds of butter—stored in cardboard boxes with stretch wrap—melted, fueling the fire and hampering suppression efforts.

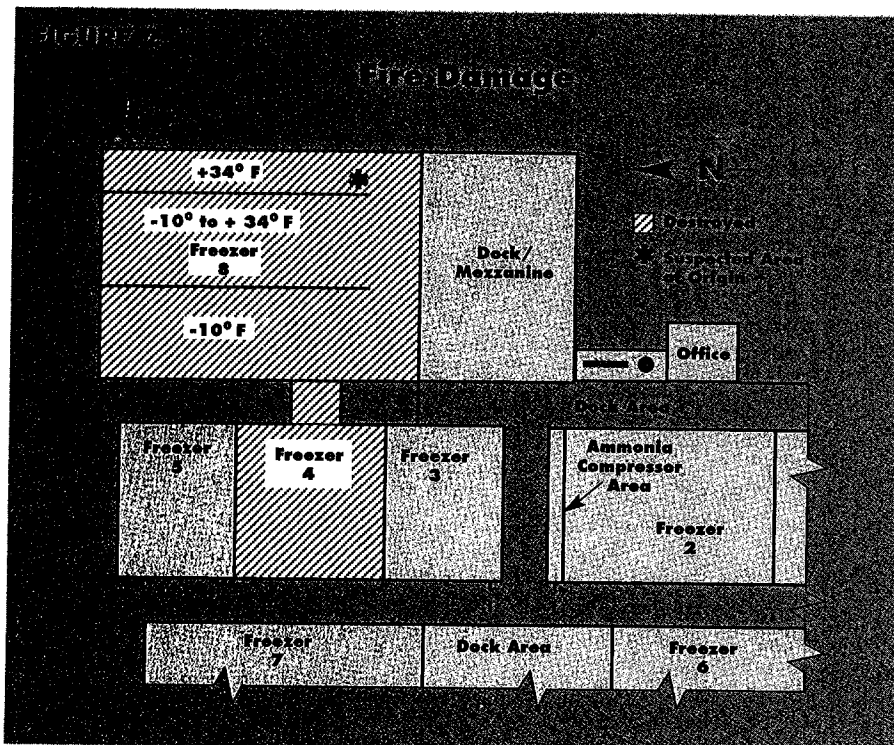
The building's structural design affected fire suppression tactics and strategies. The vertical structural members in the storage racks provided support for the roof above Freezer 8. Apparently, the fire—in combination with the loads from the roof assembly and stored commodities—began affecting the structure's integrity early in the incident. Because both the incident commander and Engine 5's officer felt there was a serious threat of collapse during the fire's early stages, they did not allow crews to enter Freezer

8. By opting to keep fire fighters out of the freezer, the officers reduced the ability of suppression crews to reach the seat of the fire and attack it. However, the two chose to reduce the risk to their crews posed by the possibility of a structural collapse. That possibility became a reality when a collapse occurred at about 4:22 p.m., 45 minutes after the first fire fighters arrived at the scene.
