Fire Investigation Summary

Apartment Building Fire

**Bremerton, Washington
November 13, 1997**

National Fire Protection Association
Fire Investigations Department

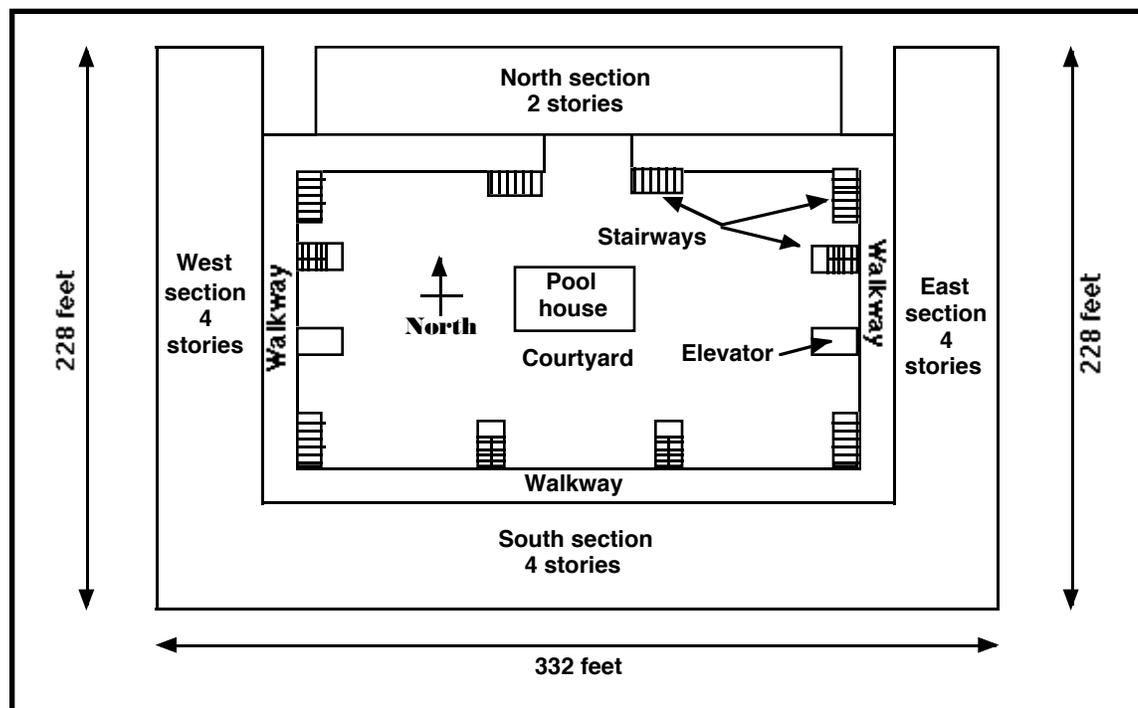
Figure 1. Site plan.

The main portion of the complex was a U-shaped structure with a separate building located in the open part of the U. (See Figure 1.) The complex had been built in two phases, the west half in 1971 and the east half in 1972.

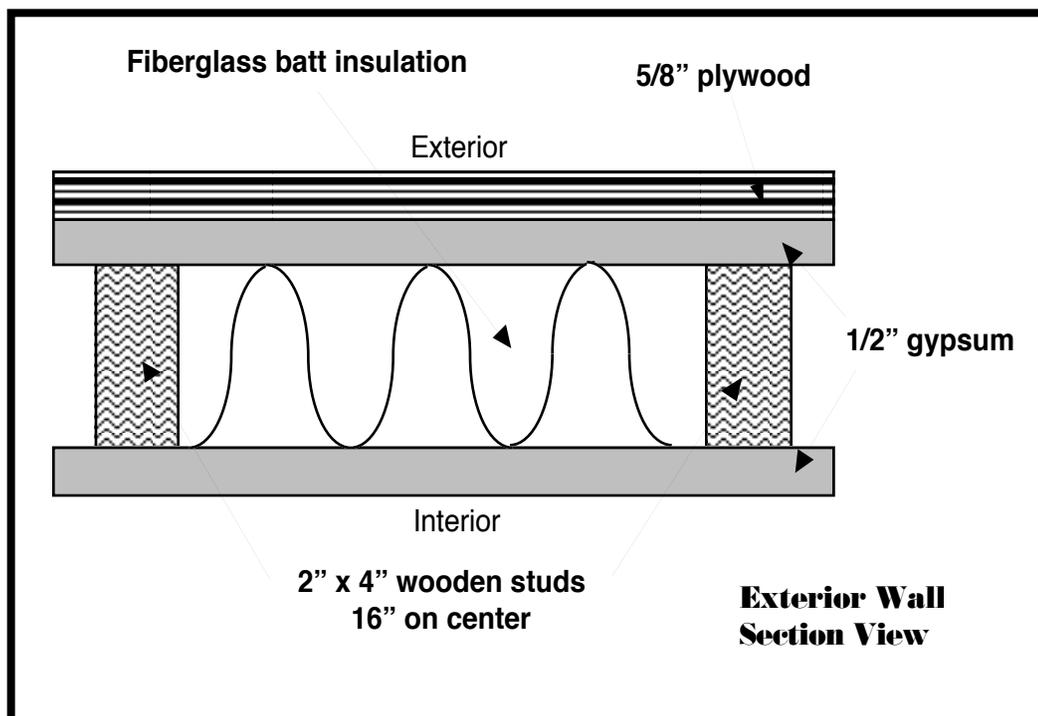
Figure 2. The configuration of the exterior walls.

The wall between the exterior walkways and the occupancies was composed of an outer layer of 5/8-in. (16-mm) plywood, 1/2-in. (13-mm) thick gypsum board (unknown fire rating), 2-in. x 4-in. wooden studs with fiberglass batt insulation in the cavities, and 1/2-in. (13-mm) fire-rated gypsum board on the apartment side.

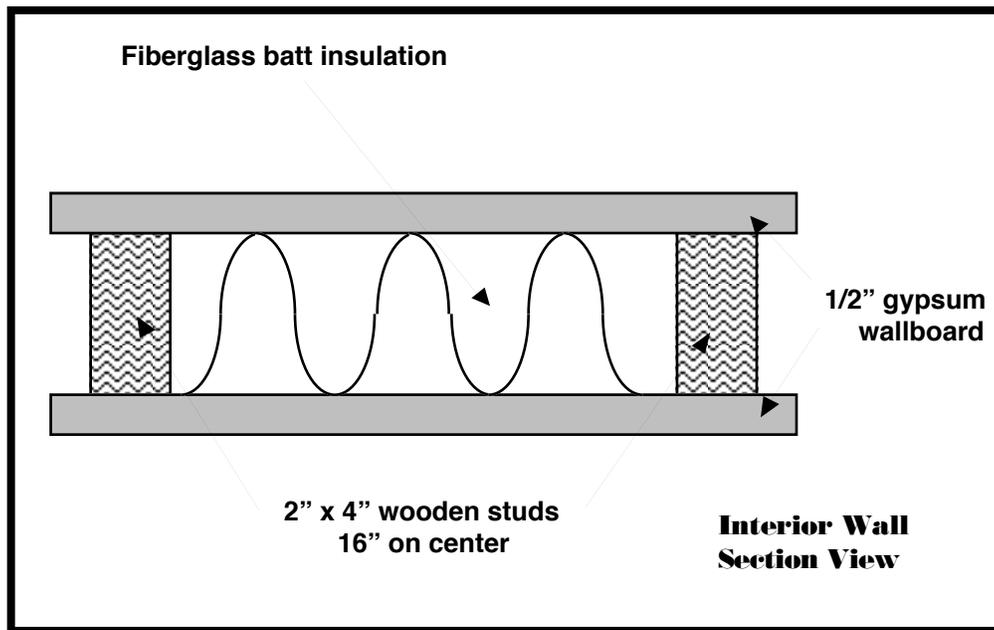
Figure 3. The configuration of the interior walls.

The interior walls within the apartment were comprised of a single layer of 1/2-in. fire-rated gypsum board attached to wooden 2-in. x 4-in. studs, which were placed 16-in. (406-mm) apart, on center. The ceiling was also comprised of a single layer of 1/2-in. (13-mm) fire-rated gypsum board attached to metal runners which, in turn,

were attached to the underside of wood floor joists, placed 16-in. (406-mm) on center. (See Figure 3.)

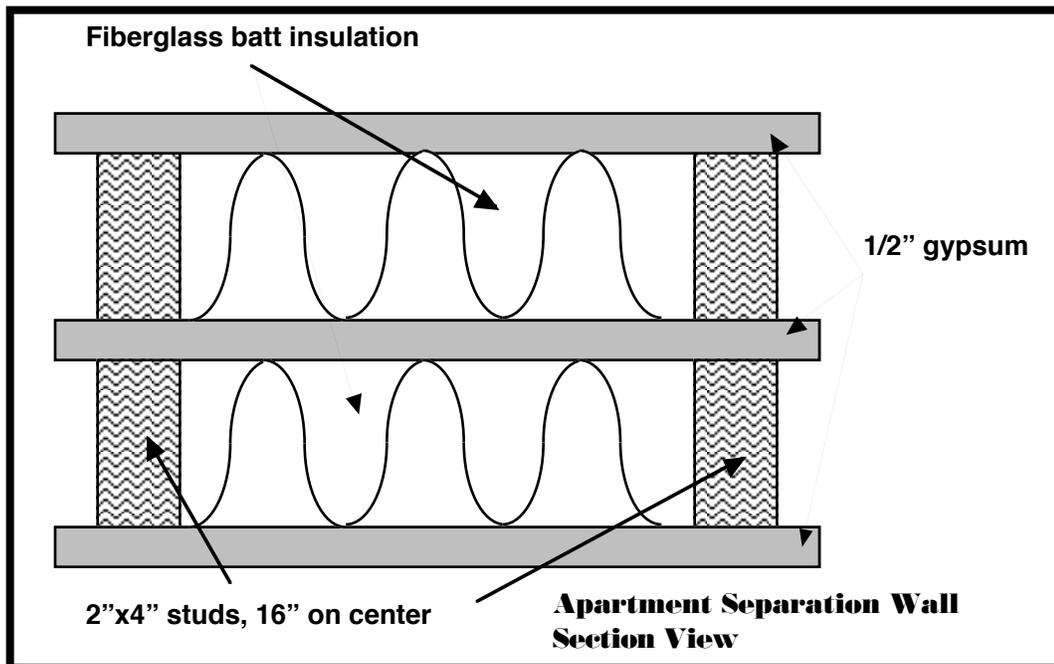
Figure 4. Configuration of separation walls.

Between the individual apartments the wall was comprised of the following:

- A 1/2-in. (13-mm) layer of fire-rated gypsum board
- 2-in. x 4-in. wood studs placed 16-in. on center with fiberglass batt insulation in the cavity
- A 1/2-in. (13-mm) layer of gypsum board (unknown fire rating)
- 2-in. x 4-in. wood studs placed 16-in. (406-mm), on center, with fiberglass batt insulation in the cavity
- A 1/2-in. (13-mm) layer of fire-rated gypsum board

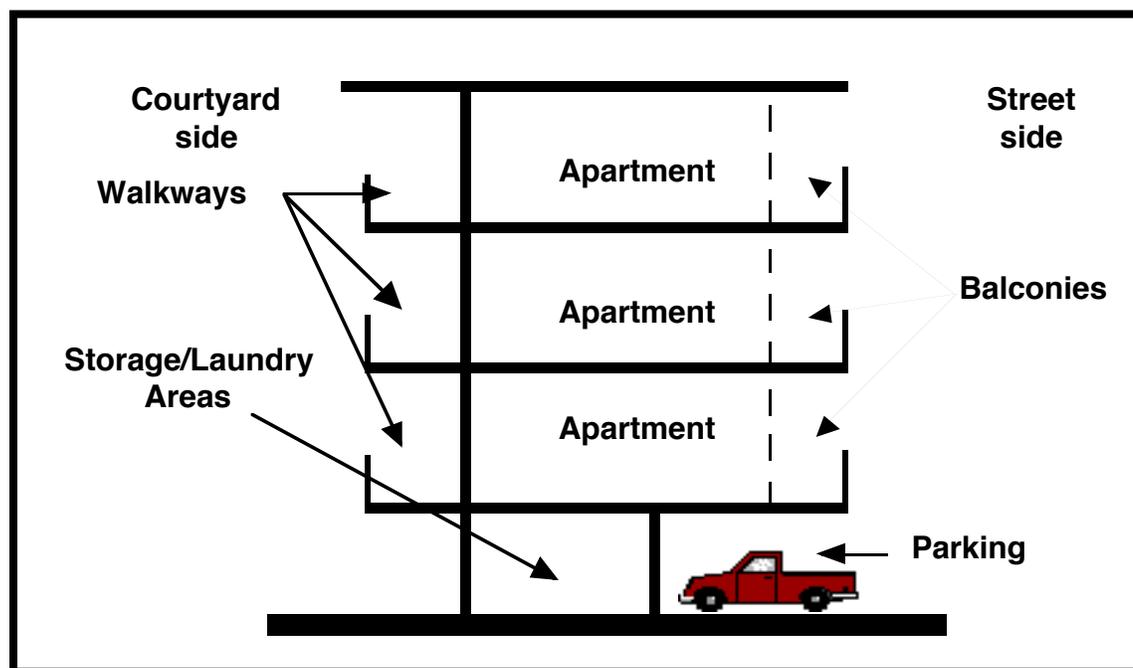
Figure 6. Elevation diagram showing the ground floor storage area, carport and three levels of apartments.

On the outboard side of the complex were carports underneath the apartment units that measured 22 ft (6.7 m) long and 10 ft (3 m) high. The walls facing onto these carports were made up of masonry block and the ceilings were made up of what appeared to be 1/2-in. (13-mm) gypsum wallboard. The fire resistance of this material was unknown. There were no suppression or detection systems in the carport areas. (See Figure 6.)

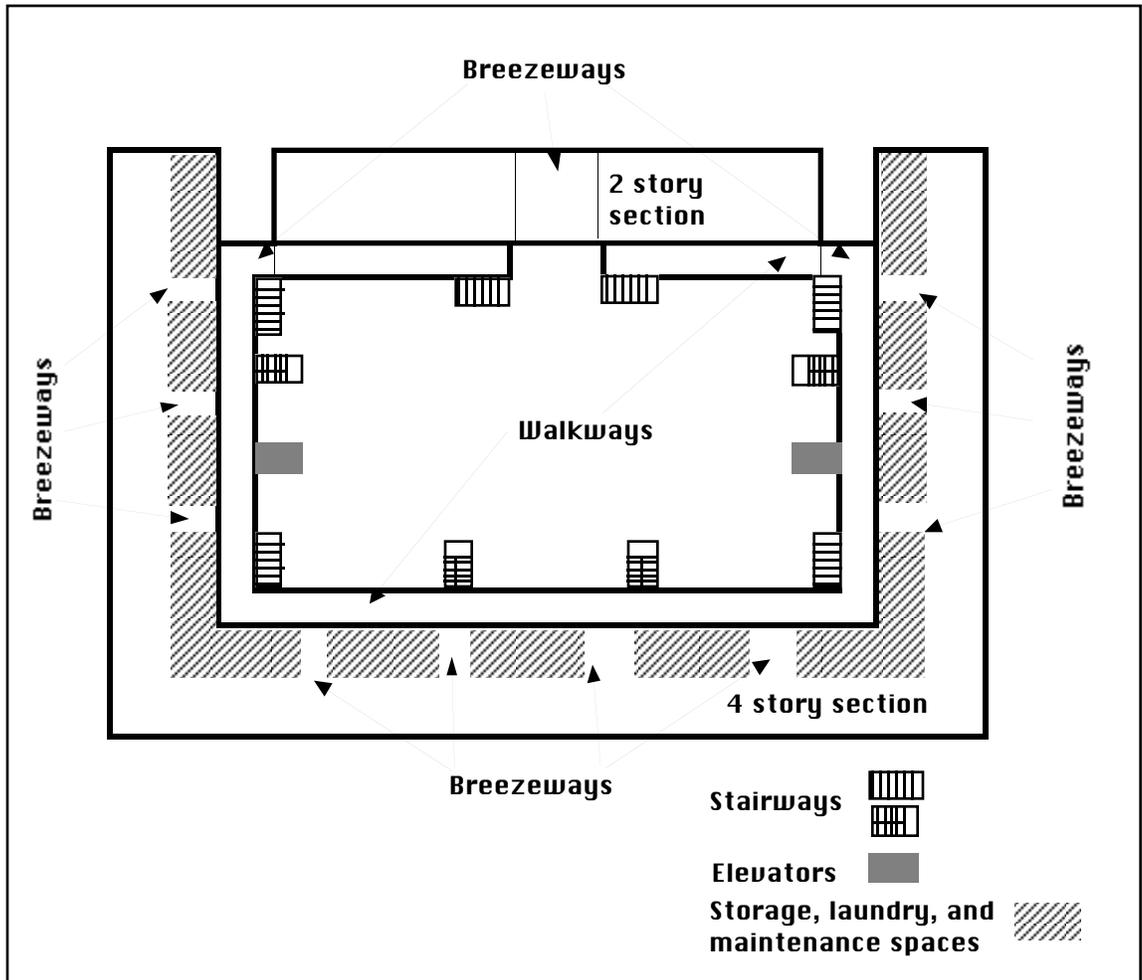
Figure 7. Site plan showing the location of the breezeways that provided access to the interior court from the outboard side of the complex.

From within the courtyard were twelve breezeways that led from the courtyard to the exterior side of the building, through the carports. (See Figure 7.)

The travel distance from the most remote unit on each level to the stairway was determined to be 75 ft (23 m). At no point during this travel would the travel path take a person through a protected enclosure.

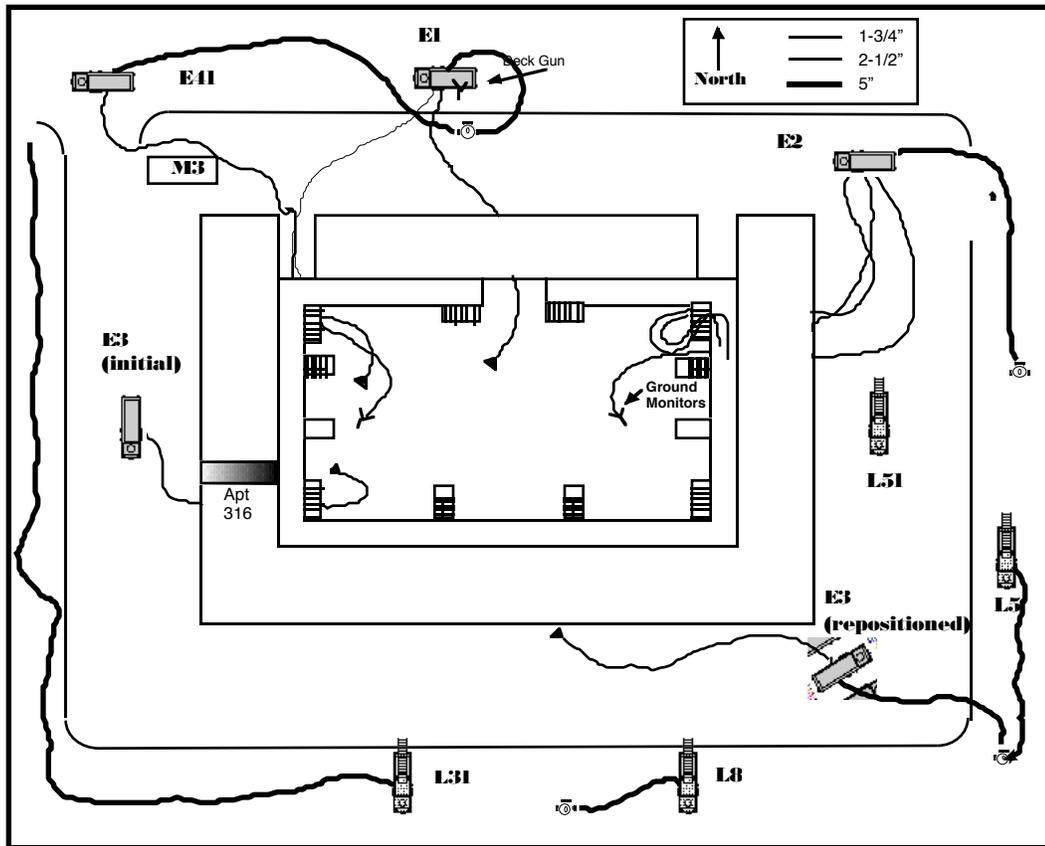
Figure 9. Fireground operations.

Ladder 81 was positioned on the east side of the occupancy on Schley Street. Water was discharged through a ladder pipe onto the building. (See Figure 9.)
